Issue 670

September
2008

THE PREVENTIVE MAINTENANCE MONTHLY

TB 43-PS-670

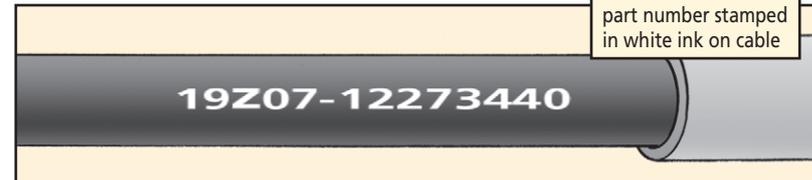
There are two manufacturers of the black service brake cables. The only way to tell the difference between the two cables is by the CAGE and part number stamped in white ink on the cable's plastic outer sheathing. There is no standard location for the stamping, so it could be anywhere on the cable.

The bad cables will have 19207-12273440 stamped on the cable. Note that the "2" in the 19207 may appear to look like a Z. These cables should be replaced and an SF 368, *Product Quality Deficiency Report*, submitted for credit and disposition instructions.

The good black service cable will be white stamped with 72166-12273440. You can continue to use these cables.

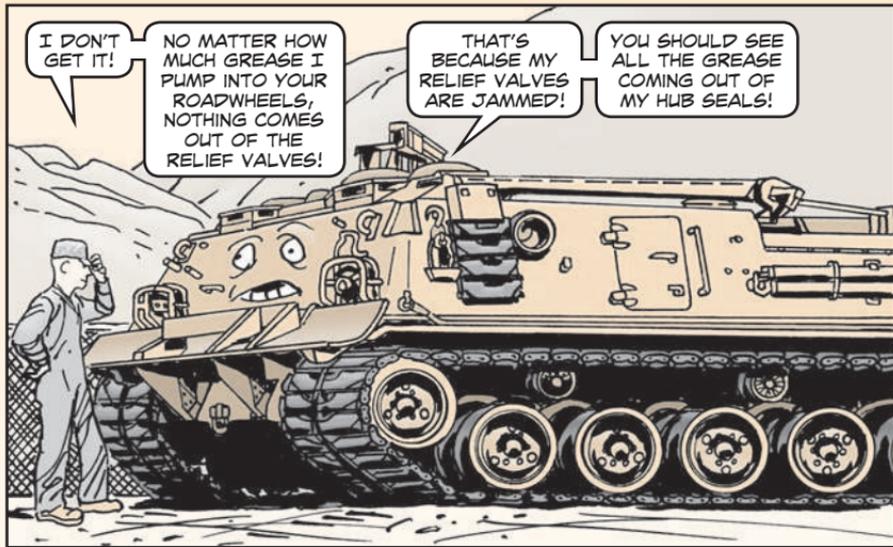
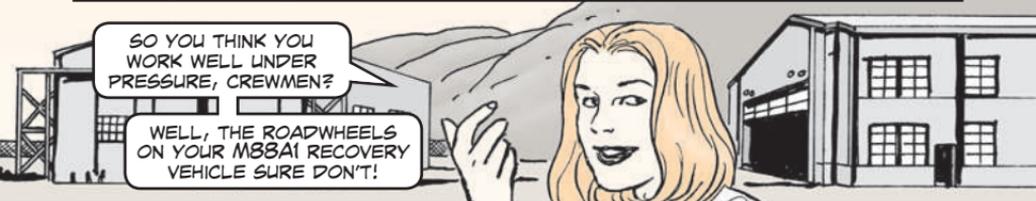
CONTENTS UNDER PRESSURE

A roadwheel relief valve that's clogged with dirt and sand won't relieve pressure when you pump in new grease. The pressure grows until something gives—usually the hub seal.

When the seal goes, so does the lube. The result is burned-out bearings.

If it slides out smoothly and pops back in when you release it, the valve's OK. If it doesn't, replace it with relief valve, NSN 4820-01-070-7670.

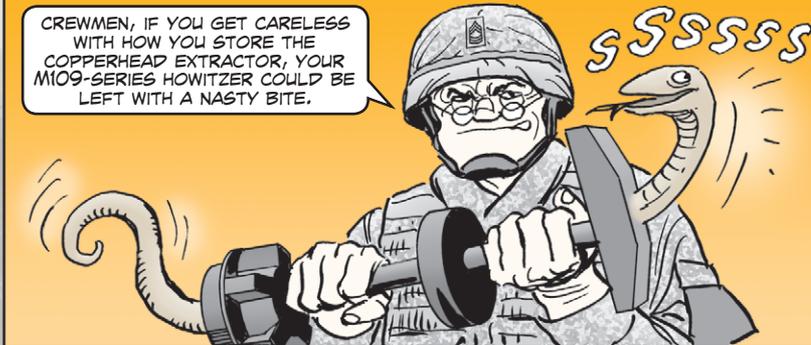
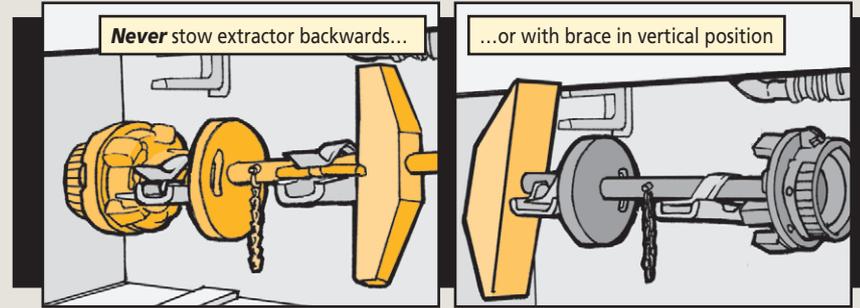
SOUNDS LIKE SOMEBODY DIDN'T PROPERLY STOW YOUR COPPERHEAD EXTRACTOR!

If you store it backwards, or with the brace in the vertical position, the brace bangs into the wiring harness that powers the slip ring contact arms. Banging wears away the harness cover and leads to arcing and electrical failure.

The same problems occur when the brace isn't tightened in place, even if the extractor is stowed properly. Vibration shifts the brace around until it snags the wiring harness.

Slide the brace forward on the extractor shaft until it touches the end of the ratchet handle. Turn the drive nut on the shaft end counter-clockwise until the brace is held firmly against the ratchet handle. Then, turn the extractor so that the brace is horizontal and facing away from the rear door when it's stored in the cab rack. That way, you avoid harness damage altogether.

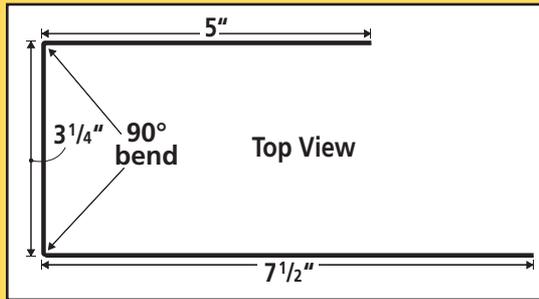
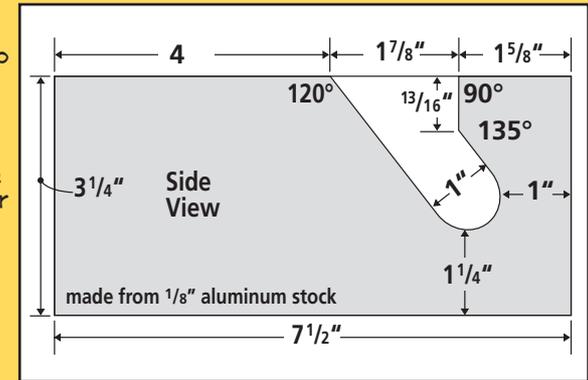
Recently we pulled maintenance on some FMTVs, and the cab doors opened when the cab was raised. Imagine our surprise! This was a hazard to anyone standing near the doors and could have damaged equipment.

Editor's note: Great idea, Mr. Shelton! Normally, FMTV cab doors don't pop open when the cab is raised. But it **can** happen if the door isn't fully latched or properly adjusted, or if the cab is bent out of alignment. And on older models, the door can open when the linkage becomes weak or loose.

TACOM LCMC approved some linkage changes to solve this problem, but not every truck was updated with the improved hardware. So if the cab door on your FMTV opens when the cab is raised, inspect the door linkage and door for proper adjustment. Check the cab structure for damage, too. And to be on the safe side, make this safety bracket.

Here's a solution I developed that I think PS readers might want to try. Using 1/8" aluminum stock, I fabricated a safety bracket that slides over the seatbelt mounting hardware and through the door's open window.

The bracket is U-shaped and acts as a lock-out device so the door won't open.

The left and right brackets are mirror images of each other. The notch fits over the bracket on the shoulder seatbelt. This simple bracket can be made using the dimensions in these drawings.

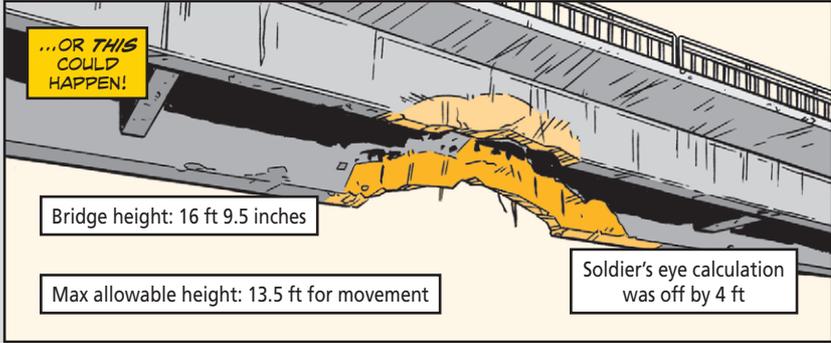
Some time back, an M916A3 tractor was hauling a hydraulic excavator on an M870A1 semitrailer. The excavator's boom collided with a pedestrian overpass. The collision backed up traffic on the five-lane interstate for 14 hours. About a million bucks in damages was the final result!
The investigation report revealed the rig's load height was almost 4 feet over the maximum allowable limit!

Bridge height: 16 ft 9.5 inches

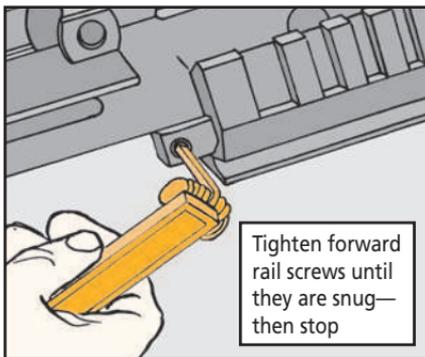
Out-of-round holes are usually caused by your repairman mistakenly thinking the forward rails don't fit. So he enlarges the holes. That makes it impossible to keep the forward rails tight.

If the studs don't fit into the holes easily, your repairman should use a rubber mallet to tap the forward rails into place. That should do the trick. Enlarging the holes accomplishes nothing but ruining the receiver.

Tighten forward
rail screws until
they are snug—
then stop

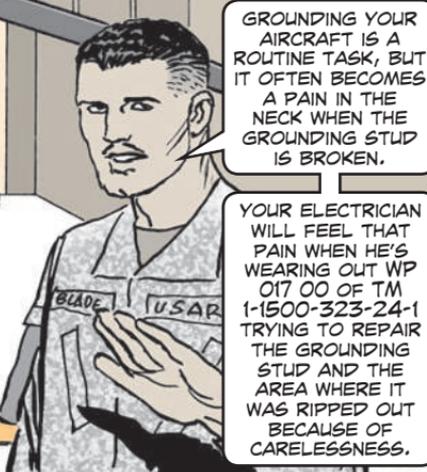
YOUR ELECTRICIAN WILL FEEL THAT PAIN WHEN HE'S WEARING OUT WP 017 00 OF TM 1-1500-323-24-1 TRYING TO REPAIR THE GROUNDING STUD AND THE AREA WHERE IT WAS RIPPED OUT BECAUSE OF CARELESSNESS.

Too many mechanics grab the ground cable and yank it like it's a vacuum cleaner cord. Is that the way you disconnect your head phones from your stereo system? Yanking means you'll be calling the electrician for repair and that means aircraft downtime.

None of this has to happen. Rushing to disconnect a ground cable leads to broken parts. The only way to disconnect from a grounding point is to reverse how you hooked it up.

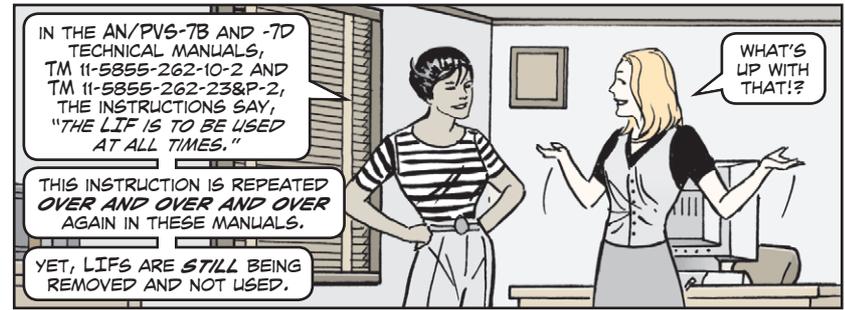
The reason for the sub is the high demand for image intensifier tubes. A lot of tubes are being replaced because of direct, bright light damage.

Your image tube cannot recover from bright light damage. The pixels in the tube will be damaged and leave a black, empty streak, an arc or spot.

Most of the light damage to image intensifier tubes could be prevented if the light interference filter (LIF), NSN 5855-01-379-1410, was being used.

One reason may be that some of you don't think you get as good an image with the LIF in place. And you're right. There is a slight reduction in system gain, but the emphasis is on the word **slight**. If you're getting too great a reduction, try cleaning the LIF using water and lens paper, NSN 6640-01-459-4239. If it's still a problem, get a new LIF!

If the LIF is dirty or scratched or otherwise damaged, it could be you're not using the sacrificial window, NSN 5855-01-246-8271. Use it! Its job is to give its life so the LIF and the tube can survive.

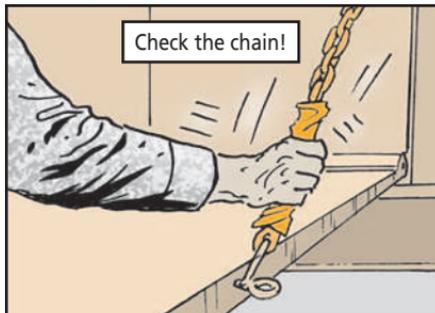
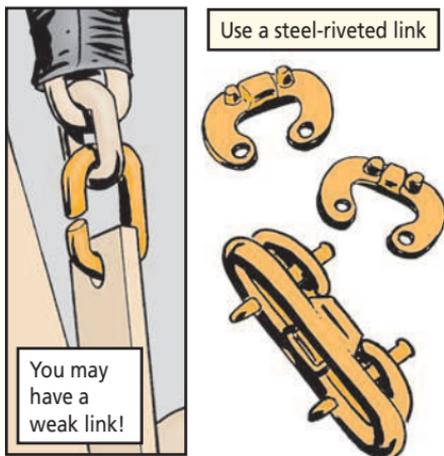
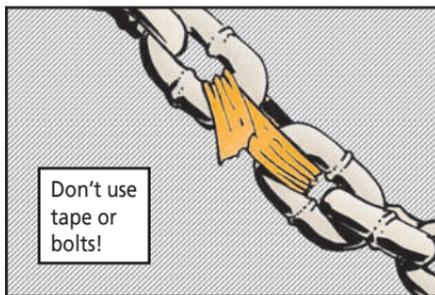
The last link of the chain—the one that joins the chain to the tailgate—might be aluminum. If it is, it just might fail! This could cause a soldier to take a tumble to the ground and be hurt.

Replace an aluminum link with a steel riveted link, NSN 4010-01-218-6340.

While you're checking this last link, check them all for rust and other signs of weakness. You might want to run that magnet over all the links just in case. Only standard welded links and the steel riveted hammer-lock type that you should use as a replacement link are authorized to be in the tailgate chain.

One other thing: don't shoot yourself in the foot by using tape or other bolts to hold the support chain together. Every link should be steel and strong.
