# THE PREVENTIVE MAINTENANCE MONTHLY

TB 43-PS-598

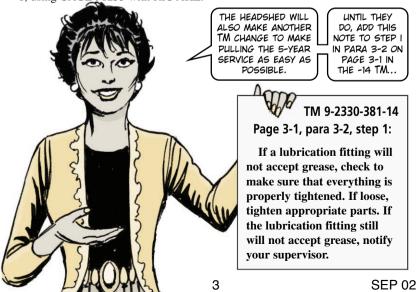
The reports also note grease fittings that won't take grease because the bolt that holds the pins and bushings in place has worked loose.

Seems the pins separate from the bushings, which causes the pins and bushings to rub. Soon the grease holes don't line up right and grease can't get where it needs to be. A loose bolt can also cause the seal to malfunction, letting in dirt and dust.

A new bolt is available that will solve this problem. Make notes in TM 9-2330-381-24P and put these new bolts to work now:

NSN 5306-01-472-3328, which is Item 4, Fig 29; Item 6 in Fig 30; and Item 6 in Fig 32.

Part number SW32291-3, which is Item 19, Fig 30. Order it on DD Form 1348-6, using CAGE 98255 with RIC AKZ.

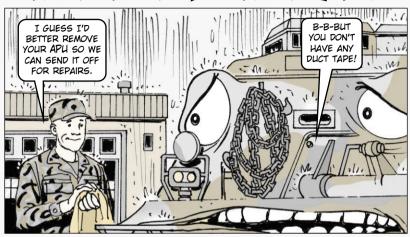
### TAKE TIME TO TAPE APU

We repair the M88A1's auxiliary power unit (APU), NSN 6115-01-047-9330, under the National Maintenance Management Repair Program. We've noticed that more and more APUs arrive needing extensive (and expensive) repairs to the engine block because of water damage.

When the APU is removed, the exhaust port is left wide open. That lets water—from rain, condensation or any other source—inside the APU. The water seeps past the exhaust valves, enters the combustion chamber and rusts the piston to the side of the cylinder.

To fix this damage, we have to hone the cylinders and fit oversized pistons and rings. All that dramatically increases repair costs.

Most of this damage could be prevented if mechanics would seal the exhaust port with a piece of duct tape immediately after removing the APU. That keeps water out and damage to a minimum.

That little piece of duct tape sounds like a good investment! It's probably a good idea to further protect the APU by shrink wrapping it before shipment to the repair site.

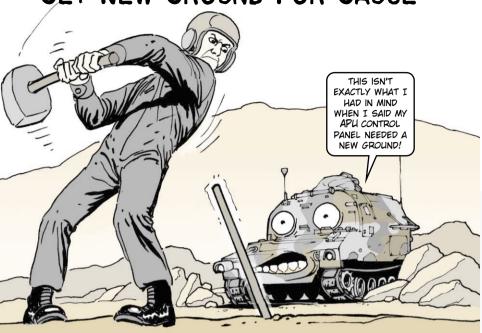
### GET NEW GROUND FOR GAUGE

**B**efore you replace a malfunctioning engine oil pressure gauge in the M992A2's APU control box, mechanics, check the ground.

The gauge is currently grounded through its mounting bracket. But since contact there can be skimpy, the gauge may not work.

The solution is to use a ground wire to attach the mounting bracket to an incoming ground that's already in place. Here's how:

- **1.** Remove the APU control box and take off the rear panel following the instructions starting on Page 7-62 of TM 9-2350-293-20-1.
- 2. Disconnect the ground lead that leads to the generator switch.
- **3.** Connect the single side of the Y connector, NSN 5935-00-900-6281, to the loose ground lead of the wiring harness.
- **4.** Fasten the ground lead from the generator switch to the double side of the Y connector using a connector adapter, NSN 5935-00-807-4109.
- **5.** Remove the nut and lockwasher from the engine oil pressure gauge mounting stud. Slip the terminal end of the electrical lead, NSN 5995-01-197-8948, over the stud and secure it with the nut and lockwasher.

6. Plug the other end of the electrical lead into the remaining empty socket of the Y connector.
7. Reinstall the rear panel

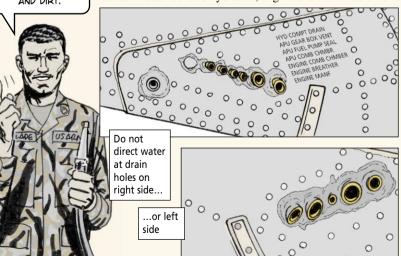
High-powered water may get your bird clean as a whistle, but it can damage the skin or knock off antennas.

When the next washing comes up, don't blast water into the drain holes at the rear of the aircraft near the cargo door. That contaminates fuel and hydraulic, engine and transmission oil.

High pressure water can also damage the finish, and wash grease out of lubricated parts. So turn down the pressure on your washers and use a nozzle that doesn't blast water.

If that's not bad enough, directing water at your bird's pitot-static system sideslip ports, static ports and tubes will cause moisture problems in the lines. That can lead to bad readings on flight instruments like your airspeed indicator and

Then your electrician has to drain and purge the pitotstatic system like it says in Task 8-25 and 8-26 of TM 55-1520-240-23-7 to get the moisture out of the lines.

TURN DOWN THE WATER PRESSURE AND USE A LITTLE ELBOW GREASE TO WASH AWAY THE CRUD.

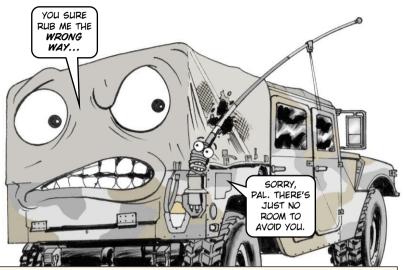
## STOP THE RUB

We are a National Guard unit that travels long distances to get to training sites. We keep our antennas tied down during these trips. Our cargo covers are always getting holes worn in them by the antenna rubbing against the canvas.

The insulation will eventually wear out, but replacing it is easier than repairing a hole in the cover, and is much less expensive.
