THE PREVENTIVE MAINTENANCE MONTHLY

TB 43-PS-578

ISSUE 578 JANUARY 2001

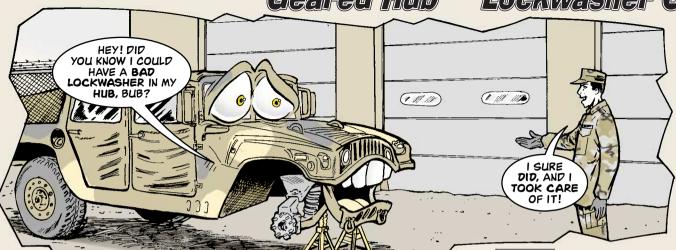
Geared Hub Lockwasher Check

TACOM Safety-of-Use Messages (SOUM) 00-014 and 00-017 called attention to lockwashers that are too thick to bend properly into the locknut slots. The tabs are also more likely to crack at the bend. The messages deadlined HMMWVs that had not been inspected and had replacement lockwashers installed.

Using these lockwashers increases the chances that the locknut will loosen and come off, which could cause a wheel to fall off. If you have not complied with the inspection criteria found in the SOUMs, or you're not sure if your vehicles are using the right lockwashers, here's what to do now:

- **3.** Look for cracks or breaks at the tab bends. If you find any cracks or breaks, replace the lockwasher with a new one, NSN 5310-01-213-4185, that is 0.090 (+/-0.010) inch thick.
- **4.** If there are no cracks or breaks, measure the lockwasher's thickness using a 7/64-in hex head wrench. If the lockwasher is as thick or thicker than the hex head wrench, replace it. If the lockwasher is thinner than the wrench, it is serviceable.

To use another lockwasher to test, match a tab on it to a tab on the lockwasher installed on the truck. If the installed lockwasher is thicker than the good one, replace it. If the installed lockwasher is the same size or slightly thinner, it's serviceable and can be left on the vehicle.

The only other alternative to the inspection procedures is to replace all lockwashers with known good ones.

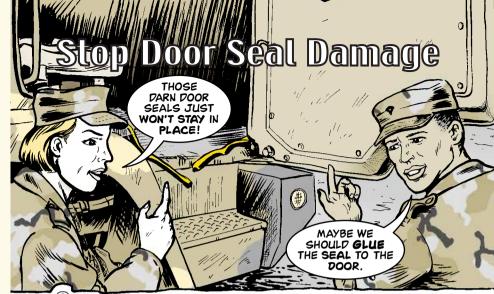
upen the doors on most FMTVs and you'll notice the door seal is pulled loose right where boots are planted when soldiers climb into the cab.

There's not much you can do to keep the seal in place—as it is designed. It just presses into place on the cab.

If all else fails to help keep the seal in place, do a little "designing" on your own.

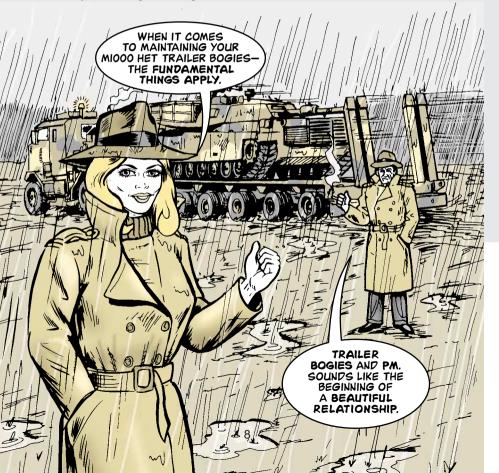
Each of those 10 bogies collects lots of dirt or mud during operation, mainly because the bottom of the bogie is like a pan. What goes into the "pan" stays there—and turns into a concrete-like substance that wears out the air brake lines.

As for the wiper seal on the suspension cylinder, it's there to keep the cylinder surface clean and to prevent dirt from scouring the oil seal at the top of the cylinder. Problem is, field conditions can loosen the seal, so it does no good at all.

Operators must make sure the bogie bottoms are free of dirt and mud after

every operation. Pressurized water will remove most of the gunk, but a little elbow grease may be needed to get it all out from around the air lines.

So, eyeball the cylinders on each bogie. If the wiper seal is not securely in place at the bottom of the cylinder, look at it closely. If it's not damaged, clean it with P-D-680 dry cleaning solvent, NSN 6850-00-281-1985.

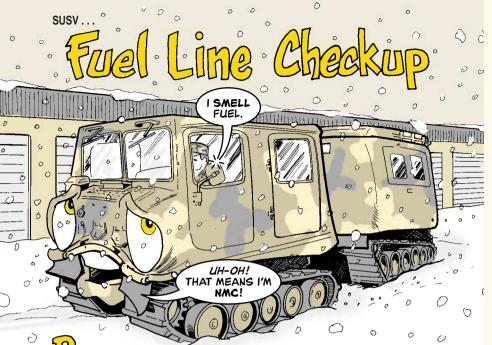
Privers, if you smell fuel when you hop into the cab of your SUSV, that vehicle is NMC.

A fuel smell means there's probably a fuel leak somewhere in the engine compartment. Any fuel leak—Class I, II, or III—needs your mechanic's attention now.

Mechanics, one area to eveball for leaks is where the fuel return lines are mounted on top of the engine.

long-term storage and engine heat. Eventually, they leak. If a line feels wet, or if its protective cover is worn off, the line is shot. Replace it with NSN 4720-01-302-2942.

An upcoming change to the -20 TM will require replacement of the fuel return line during the vehicle's annual inspection.

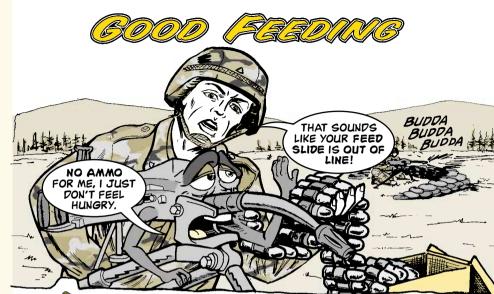
n MK 19 machine gun that won't feed is a gun that won't fire. And too many MK 19s are having feeding problems because their feed slide is out of adjustment. But, armorers, a little adjustment with PM can keep your MK 19s feeding happily.

First, check that the feed slide assembly works by doing the function test on Page 2-21 of TM 9-1010-230-23&P. If the feed slide doesn't pass the

If the feed slide passes, it's time to check the vertical cam for nicks, pits, burrs, or carbon build-up from firing. If you can't remove nicks and burrs with crocus cloth and bring the cam surface to a mirror finish, replace the vertical cam.
