ISSUE 394 FIRE POWER AIR MOBILITY

SEPTEMBER 85

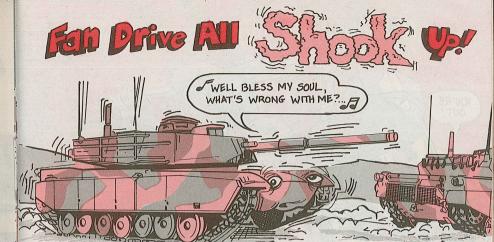
Shake, rattle and roll is taking a toll on the screws on the M1 tank's scavenger fan driveshaft.

Vibration is causing loose screws. This could lead to fan failure and possible engine performance loss because of a clogged precleaner or V-packs.

NSN 5310-00-061-4650 gets the locknut that fits all four screws. Install the screws and torque to 95-105 lb-in. Then install the locknuts and torque them to 72 lb-in.

If you don't have a failure between now and the next scheduled annual service, leave well enough alone. At the annual, just check the driveshaft for locknuts. No locknuts? Change to the new parts.

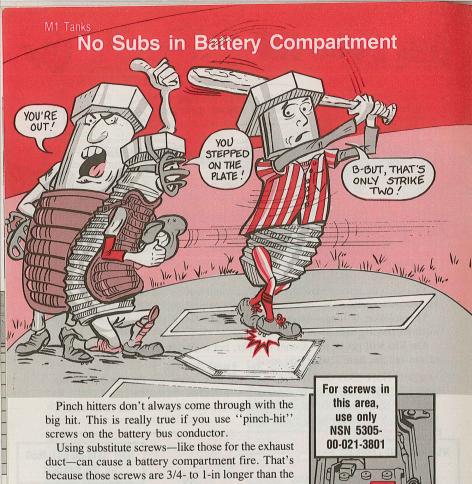
Those longer screws bottom out on the terminal board before they tighten the conductor. This lets the conductor loosen during operation.

A loose conductor causes arcing between the conductor and washers. The tank generator reads the arcing as a need for more output, increasing amperage and arcing.

It doesn't take long for the battery compartment contents to get hot enough to burn.

Use the right screws—NSN 5305-00-021-3801 for the job, so you won't have to hit "clean-up."

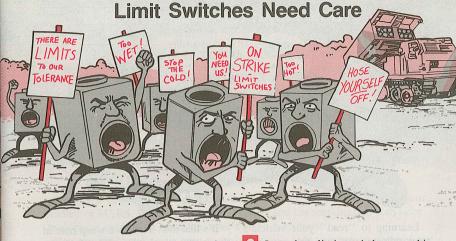
MLRS...

The cab ventilation switch gets damaged most often when the vent filtration handle is slammed from the normal to the firing positon.

If the handle stays in the firing position, the switch is activated all the time. That means early wearout.

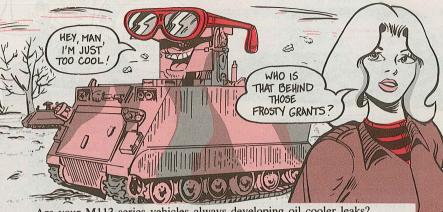
# Keep a Cool Engine

Are your M113-series vehicles always developing oil cooler leaks?

Could be an overheated engine has warped the oil cooler core. Then the gaskets won't seal, and the cooler leaks. Keeping a cool engine takes a few extra minutes, but it will save hours of

NEVER operate your vehicle with the hull drain plugs out. If you do, engine cooling air goes down the drain instead of thru the engine compartment. This causes the engine and transmission to run hot.

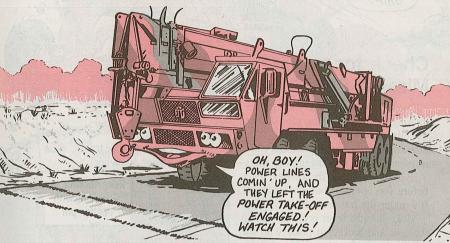
# **Head Off Surprises!**

A PTO pump left in gear—or a sticky control lever—can let the boom elevate as you drive down the road.

You could end up with phone wires—or worse, power lines—wrapped around the boom. It has happened!

Shift the pump PTO lever in the carrier out of gear before you start the engine to drive off. That will prevent surprises and reduce wear on the pump.

Shut down the engine before you engage or disengage the PTO. If you don't, you can damage the pump drive.

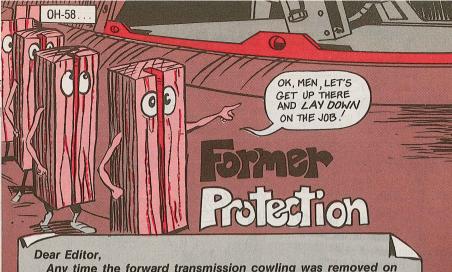
Any time the forward transmission cowling was removed on our OH-58's for maintenance or inspections, the formers were damaged by mechanics and inspectors stepping on them.

To solve the problem, I cut two 6-ft long 2x4's into 12-in sections and routed a narrow groove into one side of each section. The grooves are 1/4-in wide and 1/2-in deep. After smoothing the corners, I painted each section red.

Now, when the forward cowling is removed for maintenance or inspections, we slip these red, grooved sections over the formers on the cabin roof before climbing up top. We've eliminated about 90 percent of the repair time and maintenance cost for damaged formers. Our maintenance officer has included the fix in our unit's maintenance SOP.

(Editor's note: Now that's really grooving! Suggest you join those sections together with nylon webbing, NSN 8305-00-499-6561, to prevent the possibility of leaving one loose under the cowling. Order on DD Form 1348-6. RIC is JDC.)

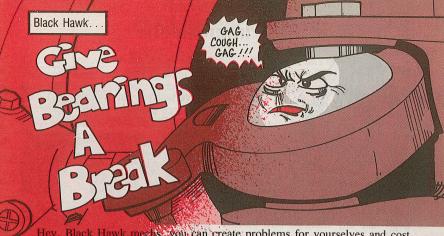
Hey, Black Hawk mee's you can create problems for yourselves and cost your unit big maintenance backs if you lube pitch control rod bearings and other Teflon-coated bearings.

Some bearings get 'hibed' when a mech spray-cleans the bifilar weights on the usan rotor head. The petroleum-based solvent drifts down on the damper bearings right under the weights.

Other Teflon bearings are being lubed when the normal red-brown residue on the bearing surface is mistaken for rust.

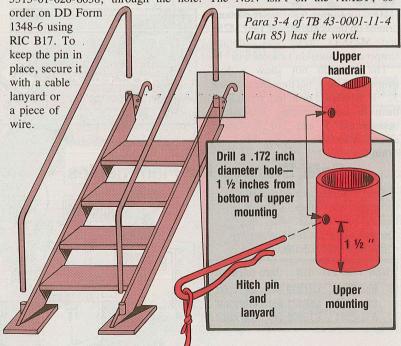
## Field Kitchen Handrail Hazard

The ladder handrails in your MKT-75 & -75A trailer-mounted field kitchen can come out of their mountings if you pull on them when going up the ladder.

Here's a fix. All you need is some wire or six cable lanyards, and six hitch pins. Set up the ladders and handrails like it says on Page 2-22 of TM 10-7360-206-13. Drill a .172-in diameter hole through each upper mounting and handrail, 1 1/2 inches from the bottom of the mounting. Then insert a hitch pin, NSN 5315-01-020-6038, through the hole. The NSN isn't on the AMDF, so
