TB 43-95-705. The Preventive Maintenance Monthly, is an official publication of the Department of the Army, providing information for all soldiers assigned to combat and combat support units and all soldiers with unit maintenance and supply duties. All information published has been reviewed and approved by the agency responsible for the equipment, publication or policy discussed. Application of the information is optional with the user. Masculine pronouns may refer to both genders. The use of product or company names does not constitute endorsement of those poducts, services or companies by the U.S. Army.

ISSUE 705 AUGUST 2011

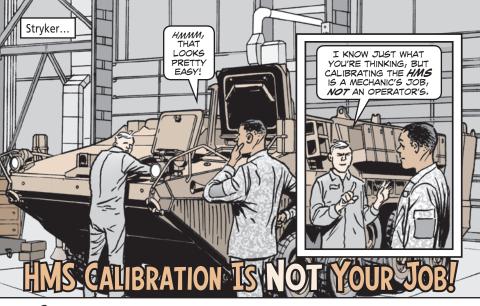
Crewmen, trying to do your mechanic's job will sometimes get you into trouble and your vehicle damaged. You don't have to look any farther than the Stryker's height management system (HMS) to learn that valuable lesson.

When the HMS isn't working properly, some of you have watched while a mechanic calibrated the system through the J2 connector on the air transport box assembly. *That doesn't look so hard*, you think to yourself.

Using your own homemade tool will just damage the system. And even worse, some crewmen will forget to remove the paperclip afterward. That leaves the J2 connector open and the system stuck in the calibration mode!

Bottom line: If your Stryker is sagging and you can't level it using the HMS controls, don't try to fix it yourself. Call your mechanic!

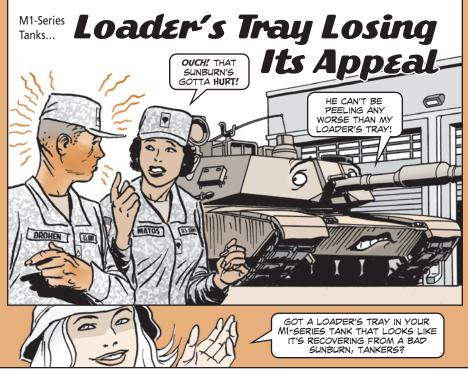
If your loader's tray is peeling, you've probably got a "3rd generation" tray, NSN 1015-01-537-0697 (PN 13010524). Those trays had a Teflon $^{\circledR}$ coating added for extra protection, but they haven't lived up to expectations.

So if your tray is peeling, stop using it now! The peeled coating can get lodged in the chamber or breech and cause problems with firing the main gun.

Get the tray replaced with a new "4th generation" tray, NSN 1015-01-590-9661 (PN 13010524-1). The Teflon® coating on these trays has been replaced with a dry film lube phosphate coating that won't peel.

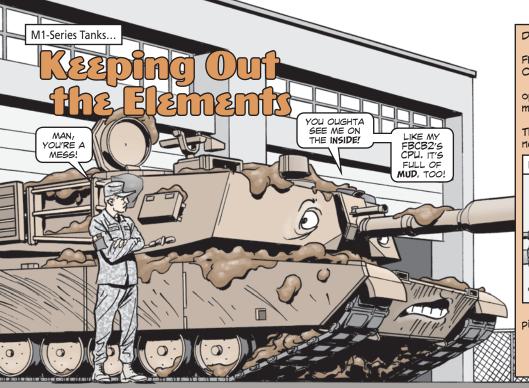
We've noticed a big problem with mud, dirt and water getting inside the $FBCB2's\ CPU$ on M1-series tanks. The biggest problem is location. The CPU is on the turret floor where dirt and water also collect.

With latches secured, CPU is better protected from moisture and dirt

Editor's note: An excellent idea, Dennis! NSN 5975-00-133-8696 brings 100 26-inch long ties. They should be long enough to secure the latches.

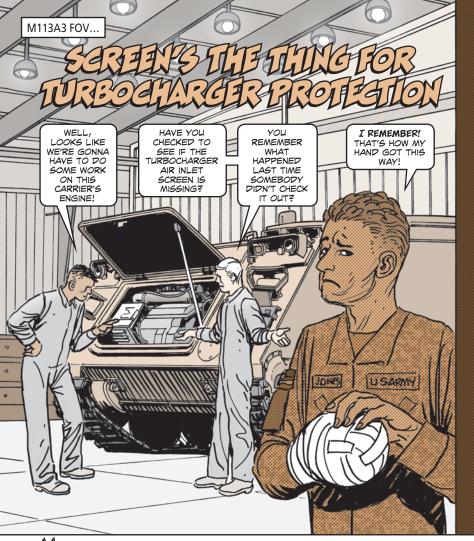
wechanics, when working around the M113A3 FOV's 6V53T engine, make very sure the turbocharger guard screen and seal are mounted on the air intake horn.

Without the screen, just about anything can be sucked into the turbocharger's impeller. The turbocharger is damaged by any debris that gets sucked inside. Even more importantly, you'll be in a world of hurt if your fingers and hands get too close to the intake.

If the screen is missing, order a new one with NSN 2815-01-281-4930. That NSN also brings the seal. You'll find them listed as Item 24 in Fig 39 of TM 9-2815-205-34P (Oct 05).

Until the new screen and seal arrive, you can use the turbo protection shield, NSN 4910-01-127-7959, while working around an open turbocharger air intake horn. This shield is part of the direct support special tools kit and is listed as Item 25 in Fig 68 of TM 9-2815-205-34P. Remember, this shield is a special tool, not a repair part. It should be used only as a **temporary** fix.

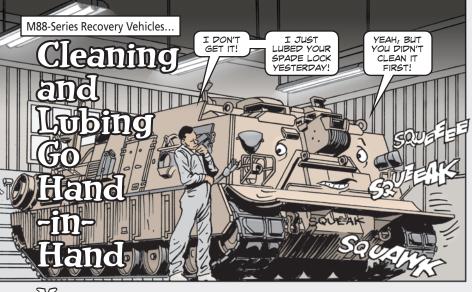
lechanics, the spade lock on M88-series recovery vehicles needs more than lube to keep it working right. You have to give it a good cleaning, too.

The spade lockpin gets coated with dirt, mud and sand. As the lockpin goes up and down, that gunk gets pulled inside the mechanism. Pretty soon, you have a spade that won't lock or release.

- Clean off the worst of the dirt, mud, sand and old grease with a rag. Loosen any hardto-remove gunk by scrubbing it with a nylon brush like NSN 7920-00-061-0037.
- Wipe the spade lockpin again with a clean cloth. If dirt still shows on the cloth, keep cleaning.
- Once the mechanism is clean, apply a very light coat of GAA to the exposed part of the spade lockpin. If you're in a desert environment, skip this step. In the desert, grease just attracts more sand.
- 4. Pump GAA into the grease fitting on the right side of the pin housing quarterly. Old, dirty grease will start coming out of the relief valve. Keep pumping until you see new grease, then wipe the old grease off the relief valve.
- a the he with GAA

Operate the spade lock a few times. That ensures the lube is spread evenly throughout the entire mechanism.

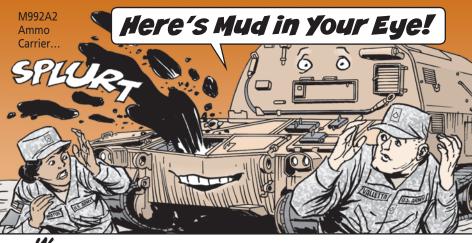
When you've finished lubing the final drive U-joints, your job's not over. At least not until you wipe away the excess grease.

So save yourself a whole bunch of trouble. It only takes an extra second or two to wipe the excess grease off the U-joint's grease fitting. Even if you miss it, you're still supposed to wipe the fire sensor lenses with a damp rag as part of your before-operations PMCS.

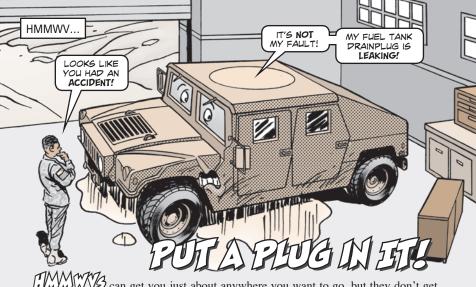
Unfortunately, that gas mileage will get a whole lot worse if you've got a leaky fuel tank drainplug. And that's in addition to the unwanted attention you'll get from your environmental folks!

The drainplug consists of a metal screw surrounded by a rubber gasket. If the drainplug is over-tightened, the sharp edge of the hole may cut the rubber. Even if the drainplug's properly seated, the rubber will eventually deteriorate. Either way, you've got a fuel leak.

Check the plug before operations as part of your PMCS. A leak should be reported immediately. But even if there's no leak, you should search for signs of deterioration. If the rubber has hardened or is overly soft and smooshy to the touch, report it.

surrounded by rubber

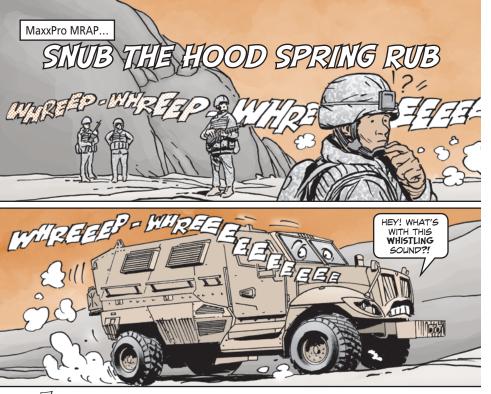
The MaxxPro's hood spring is known to rub against the engine's air intake cooler when the hood is being opened and closed.

Enough rubbing creates a hole in the cooler. That causes an air leak and a loss of intake pressure. Then the engine doesn't get enough cool air to keep it running smoothly—especially in hot weather.

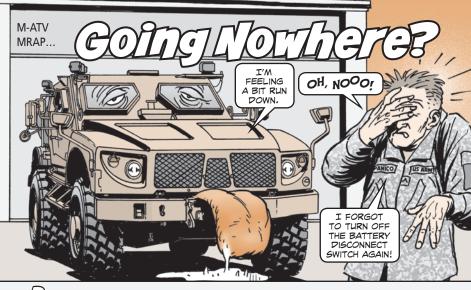
rivers, make sure your MRAP M-ATV's battery disconnect switch is turned off after the day's run.

If the switch is left on, the batteries can lose their charge in just a week or two. No juice means your M-ATV needs a slave start—or you'll be going nowhere!

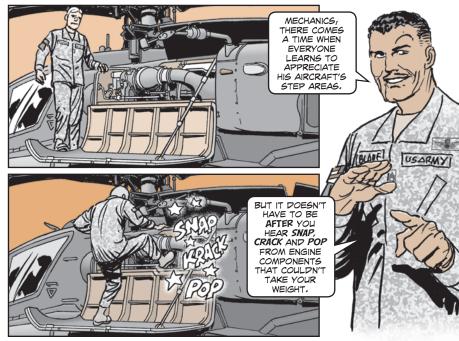
Always use a work stand, a work platform or aircraft step areas for your feet. That way, you avoid breaking the engine's temperature bulb, alternator connector, starter speed sensor wiring, bleed air tube and the hydromechanical unit (HMU). If you step on the HMU, you can break the shaft that goes into the accessory gearbox, including the spline. When your feet contact the engine, that puts the fuel line at risk, too.

You may not notice that damage has occurred, but the internal connections and wiring to the starter speed sensor will let you know. For example, the starter will not sense the engine speed and won't shut off after the engine reaches optimum speed. So the pilot has to shut off the starter manually.

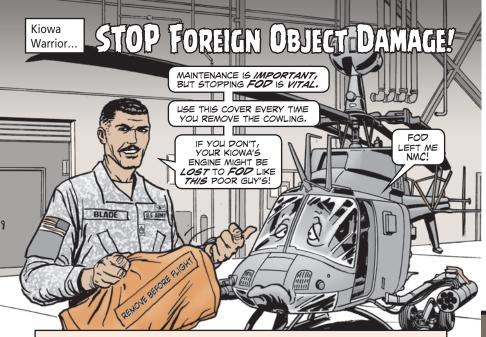
When we perform maintenance on our Kiowa Warrior, the air induction cowling gets removed for access to the engine.

The cowling has open crevices and other places where nuts, bolts, and screws could fall in and become lodged in the cowling. When the cowling is reinstalled and the aircraft is started, those small parts work loose and are sucked into the engine. That always spells disaster!

Something as small as a tiny washer can cause a perfectly good engine to be lost to FOD.

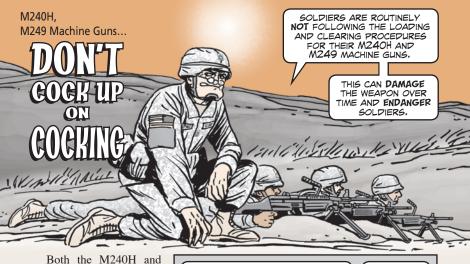
Both the M240H and M249 should be in either the FIRE position with the bolt fully forward or in the SAFE position with the bolt locked to the rear.

If the gunner puts the weapon on SAFE with the bolt forward and then tries to charge the gun, he jams and/or damages it.

Pulling the bolt halfway back and then putting the selector in SAFE causes the sear to rise, blocking the bolt from moving forward. If the gunner then tries to charge the weapon, he damages the sear, plus he can cause the machine gun to jam.

The cocking handle also needs to be locked fully forward after you lock back the bolt. The handle should click into place if it's fully forward. If the handle is not locked forward, it will bang against the cocking handle stop during firing. That wears out the receiver rails and the handle. There is no fix for worn out rails. The weapon must be replaced.

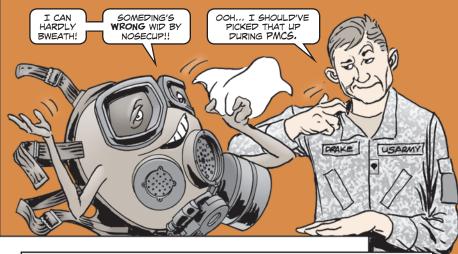
In my work with the MAIT at Camp Casey, Korea, I often run into M40/M42 masks in which the nosecup has pulled away from the back of the front voicemitter housing.

When a Soldier clears his mask or exhales, all of the air is supposed to be blown out the air outlet. If the nosecup is unsealed from the front voicemitter housing, contaminated air can remain in the mask and be inhaled by a Soldier. And the PATS test doesn't always pick up a loose nosecup.

If the nosecup is not seated around the outlet valve body or has pulled away from the back of the front voicemitter housing, the facepiece should be replaced.

Make very sure to check for a loose nosecup during PMCS

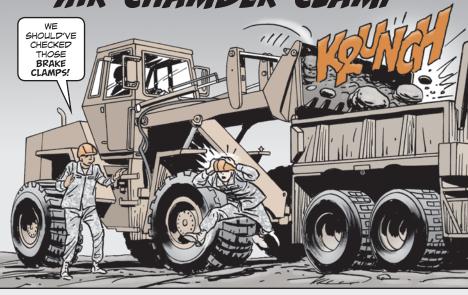
OPERATORS, VIBRATION LOOSENS THE NUTS AND BOLTS THAT HOLD TOGETHER THE BRAKE ACTUATOR AIR CHAMBER CLAMP.

WHEN THAT HAPPENS, AIR LEAKS FROM THE CHAMBER.

So grab the clamp to see if it's loose. If it is, get your mechanic to re-torque the nuts to 70-80 lb-ft.

Between scheduled 250-hr services, look for loose nuts, shiny spots or rust around the bolt heads and nuts on both the front and rear air brake chambers. If you spot any, tell your mechanic.

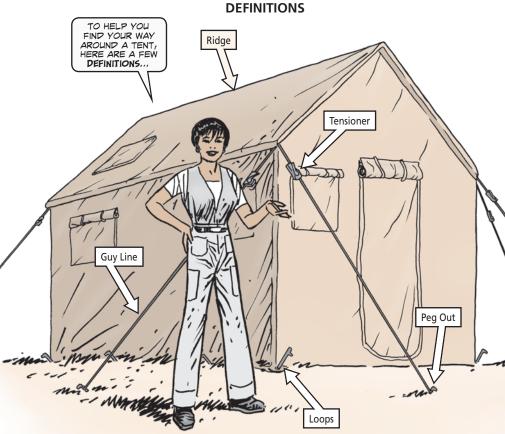
Guy line—Also known as line, guy or guy rope. This is a single line or rope extending from the tent. When all guy lines are pinned to the ground and tightened, they anchor the tent and make it stable.

Tensioner—Also known as runner. This is a wooden or plastic bracket attached to the guy line. It's used to tighten or slacken the line.
