Issue 670

September
2008

THE PREVENTIVE MAINTENANCE MONTHLY

TB 43-PS-670

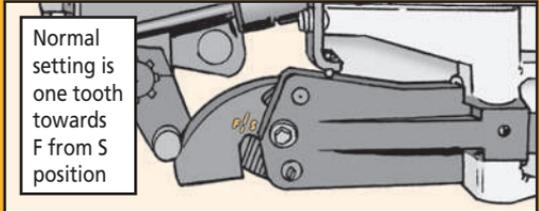
But setting the cam to the F (fast) setting doesn't speed up the recoil. It just forces the stub base to be ejected more aggressively. That causes extra stress and wear on the breech components and can lead to premature failure.

Normal setting is one tooth towards F from S position

So, check the cam in your tank now. The normal operating position is one tooth towards F from the S (slow) position. Then, adjust the cam only if it becomes necessary—when the stub bases eject too slowly because of cold weather.

You'll find the instructions for adjusting the cam starting on Page 3-266 of TM 9-2350-264-10-2, Page 3-160 of TM 9-2350-288-10-2, and Page 3-188 of TM 9-2350-388-10-2.

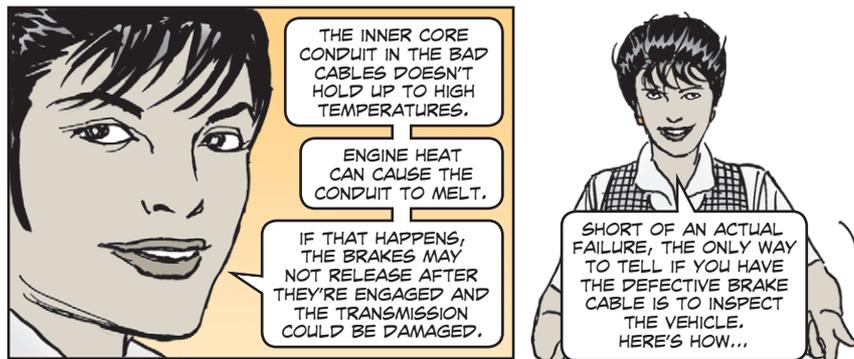
The bad cables will have 19207-12273440 stamped on the cable. Note that the "2" in the 19207 may appear to look like a Z. These cables should be replaced and an SF 368, *Product Quality Deficiency Report*, submitted for credit and disposition instructions.

Access the service brake cable through the exhaust duct door panel assembly. Loosen the hose clamp holding the outer sheathing on the cable in place.

If the service brake cable is green, you're good to go. However, if the cable is black, you're not finished.

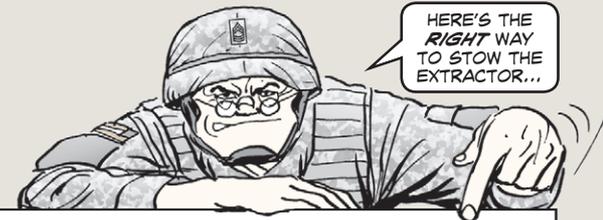
If you store it backwards, or with the brace in the vertical position, the brace bangs into the wiring harness that powers the slip ring contact arms. Banging wears away the harness cover and leads to arcing and electrical failure.

The same problems occur when the brace isn't tightened in place, even if the extractor is stowed properly. Vibration shifts the brace around until it snags the wiring harness.

Slide the brace forward on the extractor shaft until it touches the end of the ratchet handle. Turn the drive nut on the shaft end counter-clockwise until the brace is held firmly against the ratchet handle. Then, turn the extractor so that the brace is horizontal and facing away from the rear door when it's stored in the cab rack. That way, you avoid harness damage altogether.

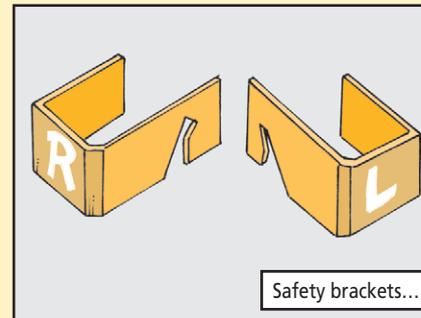
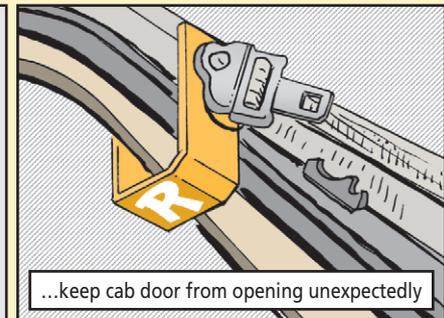
Editor's note: Great idea, Mr. Shelton! Normally, FMTV cab doors don't pop open when the cab is raised. But it **can** happen if the door isn't fully latched or properly adjusted, or if the cab is bent out of alignment. And on older models, the door can open when the linkage becomes weak or loose.

Safety brackets...

...keep cab door from opening unexpectedly

TACOM LCMC approved some linkage changes to solve this problem, but not every truck was updated with the improved hardware. So if the cab door on your FMTV opens when the cab is raised, inspect the door linkage and door for proper adjustment. Check the cab structure for damage, too. And to be on the safe side, make this safety bracket.

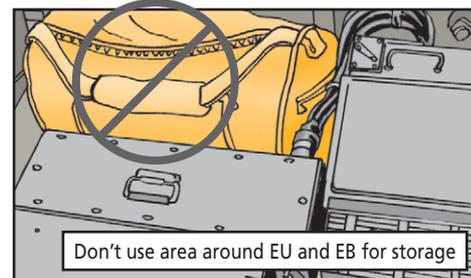
Make sure all four bolts that hold the EB to the battery box are in place and are tightly screwed in with the correct washers and gaskets. Often the two bottom bolts are forgotten and that can let water into the EB.

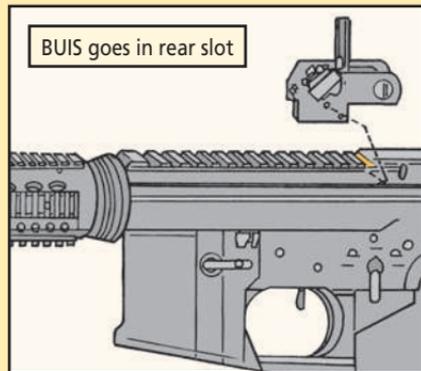
For the M4/M4A1, the line on the left-side cam must align with the 300-m mark. For the M16A4, the line should be between the 300-m and 400-m marks.

Good question. First of all, for accurate zeroing, the BUIS must be in the last slot to the rear.

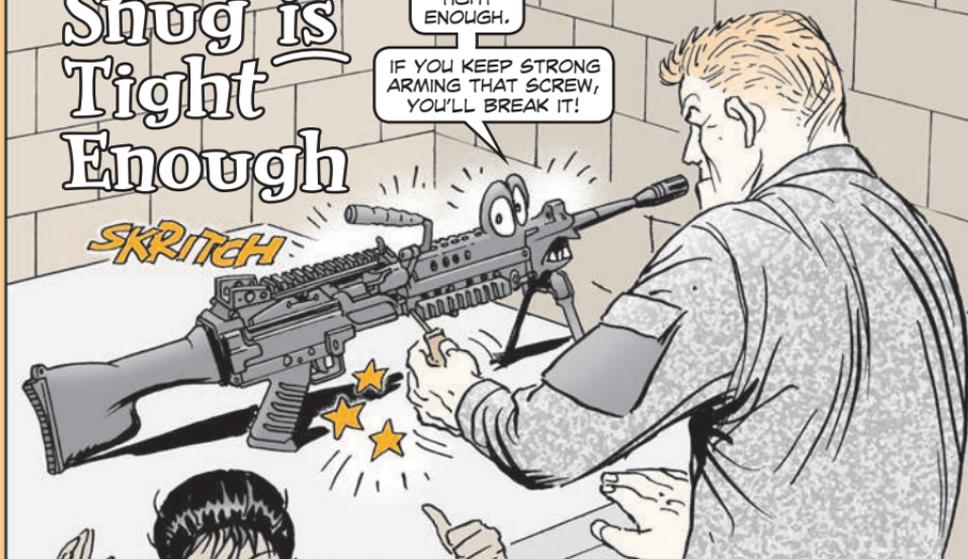
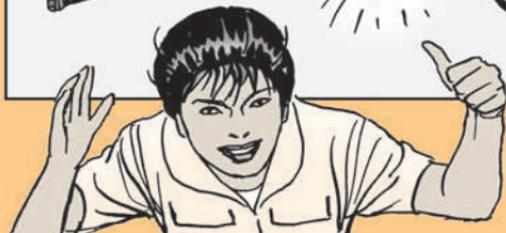
TIGHTENING AND TIGHTENING
THE SCREWS FOR THE M249
MACHINE GUN'S FORWARD
RAILS ISN'T NECESSARY.

The screws are self-locking, so once they're tightened snug the forward rails should be tight. If you continue to tighten the screws, you strip or break them.

Out-of-round holes are usually caused by your repairman mistakenly thinking the forward rails don't fit. So he enlarges the holes. That makes it impossible to keep the forward rails tight.

If the studs don't fit into the holes easily, your repairman should use a rubber mallet to tap the forward rails into place. That should do the trick. Enlarging the holes accomplishes nothing but ruining the receiver.

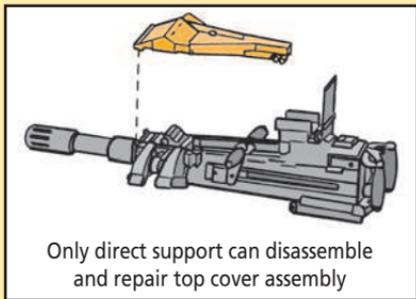
TM 9-1010-230-23&P is confusing on what level of maintenance should disassemble the MK 19's top cover assembly. WP 004700-1 says the armorer should inspect, remove and repair the top cover assembly.

But the note on the next page says not to disassemble the top cover unless you need to replace a part. In the repair parts list on WP 010500-3/4, it states that all the top cover repair parts are at the direct support level. So what's right?

Only direct support can disassemble and repair top cover assembly

The armorer is **not** authorized to disassemble the top cover assembly. The only part of the assembly the armorer should inspect is the latch mechanism. All repairs and disassembly of the top cover should be done by support. The TM will be changed to make this clear. Thanks for pointing this out.

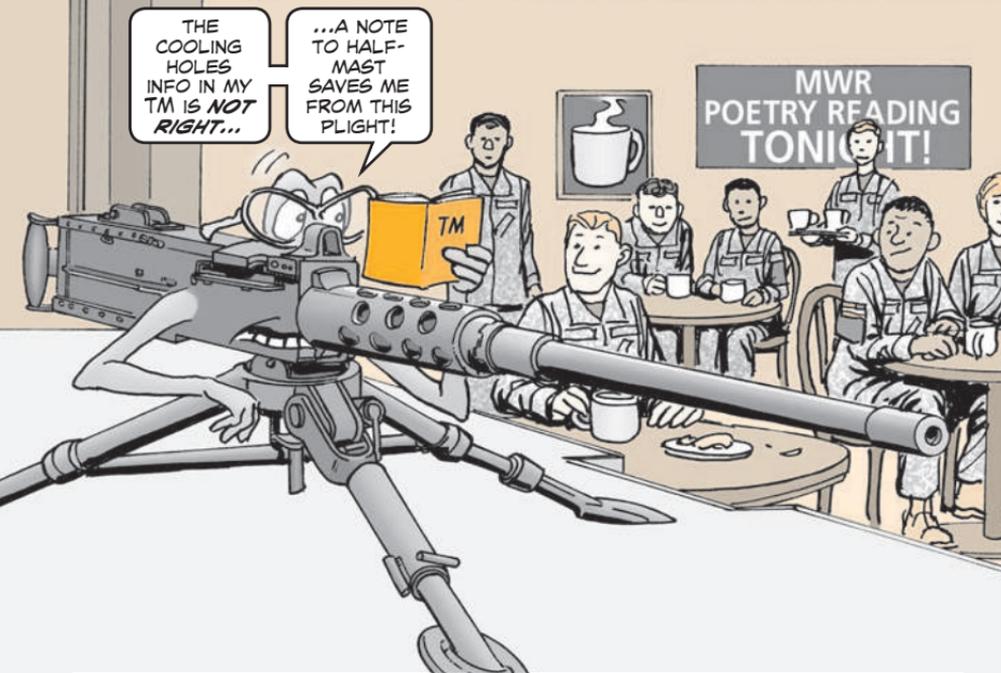
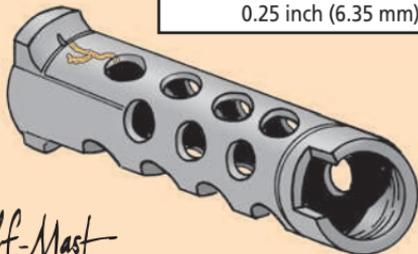
TB 9-1000-247-34 says that cracks up to 1/4 inch long are permitted at cooling holes, but Step 3 on WP 0020 00 in TM 9-1005-213-23&P says "Cracks up to 0.025 inch (0.635 mm) maximum in length are permitted at holes". That's quite a difference. What's right?

Cracks can't be longer than 0.25 inch (6.35 mm)

Step 3 in the TM should read 0.250 inch (6.350 mm), so make a note in your TMs until this is corrected. The rest of Step 3 is correct: "No more than four cracks allowed per support. No more than two cracks allowed in succession in any direction. Original surface imperfections are permitted."

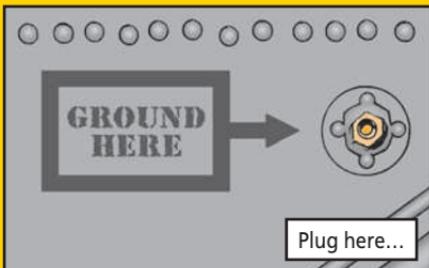
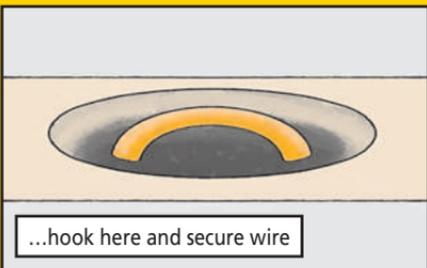
Too many mechanics grab the ground cable and yank it like it's a vacuum cleaner cord. Is that the way you disconnect your head phones from your stereo system? Yanking means you'll be calling the electrician for repair and that means aircraft downtime.

Carelessness is another key killer of grounding studs. A dropped tool, a misplaced foot, or a poorly placed maintenance stand could lead to a snapped grounding stud if the wire gets caught or tangled in anything.

None of this has to happen. Rushing to disconnect a ground cable leads to broken parts. The only way to disconnect from a grounding point is to reverse how you hooked it up.

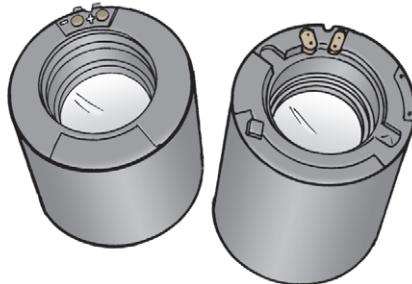
The reason for the sub is the high demand for image intensifier tubes. A lot of tubes are being replaced because of direct, bright light damage.

Your image tube cannot recover from bright light damage. The pixels in the tube will be damaged and leave a black, empty streak, an arc or spot.

Most of the light damage to image intensifier tubes could be prevented if the light interference filter (LIF), NSN 5855-01-379-1410, was being used.

One reason may be that some of you don't think you get as good an image with the LIF in place. And you're right. There is a slight reduction in system gain, but the emphasis is on the word **slight**. If you're getting too great a reduction, try cleaning the LIF using water and lens paper, NSN 6640-01-459-4239. If it's still a problem, get a new LIF!

If the LIF is dirty or scratched or otherwise damaged, it could be you're not using the sacrificial window, NSN 5855-01-246-8271. Use it! Its job is to give its life so the LIF and the tube can survive.

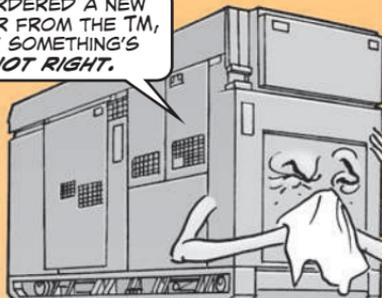
THAT'S
'CAUSE
THE TM
HAS THE
WRONG
NSN!

Dear Sergeant D. G. Y.,
Never doubt a chief.
They know! The right NSN
for Item 34 is NSN 2940-
01-559-9941. And the NSN
for Item 35 is NSN 2940-
01-560-8766. Correct the
part number, too. The right
part number for Item 34 is
P533781.

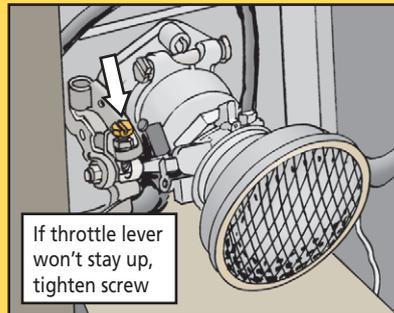
- The throttle lever constantly gets out of adjustment. Its screw loosens from vibration so much that when you push up the lever at shutdown, it drops right back down and the engine doesn't shut off. During PMCS, push the lever up and release it. If the lever won't stay up, tighten its screw, but not so tight that the lever is difficult to move.

If throttle lever won't stay up, tighten screw

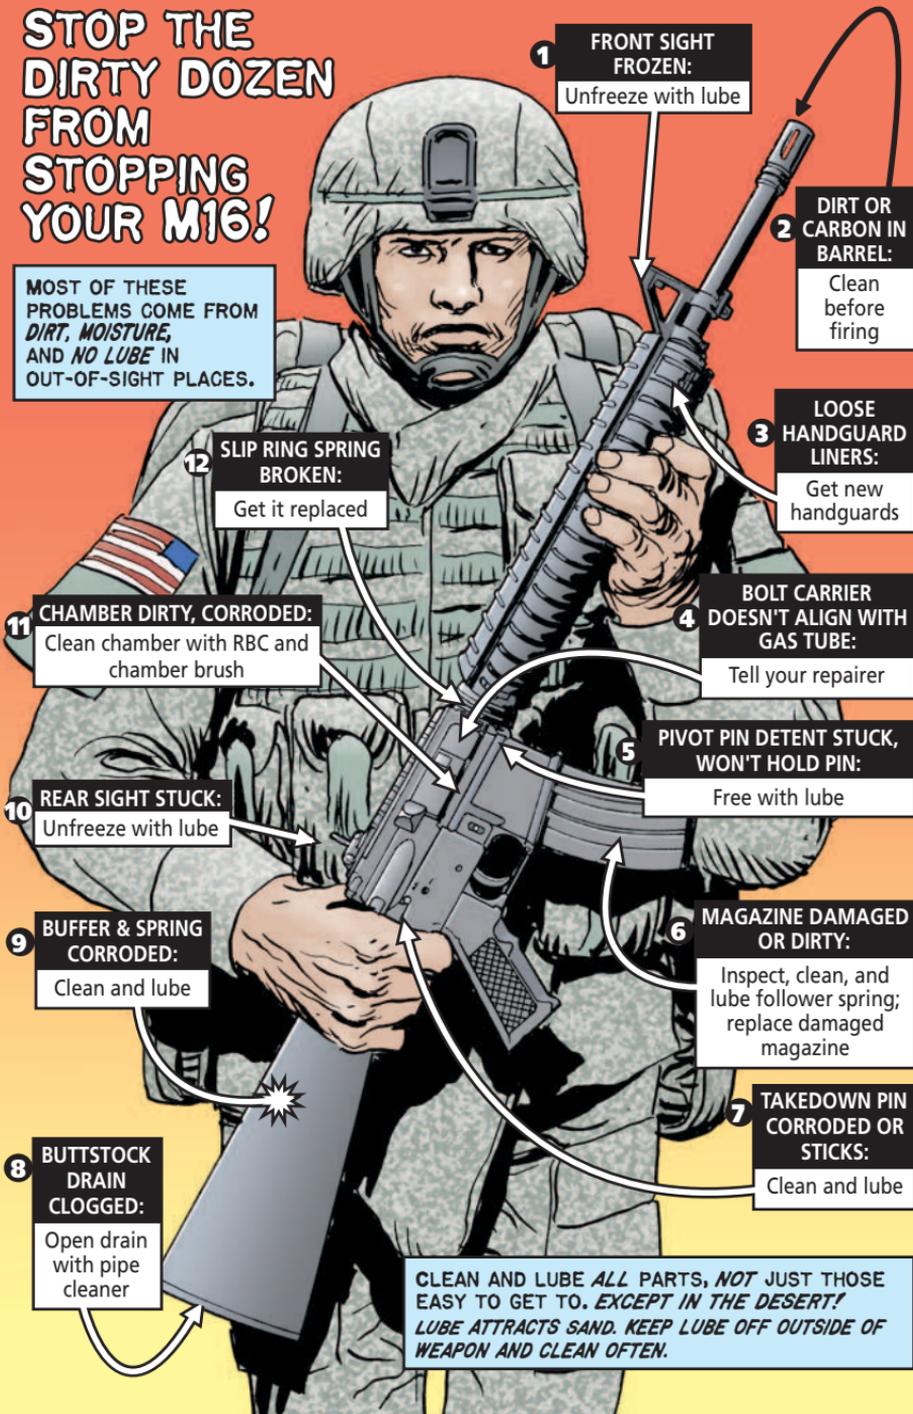
STOP THE DIRTY DOZEN FROM STOPPING YOUR M16!

MOST OF THESE PROBLEMS COME FROM *DIRT, MOISTURE, AND NO LUBE* IN OUT-OF-SIGHT PLACES.

1 FRONT SIGHT FROZEN:
Unfreeze with lube

2 DIRT OR CARBON IN BARREL:
Clean before firing

3 LOOSE HANDGUARD LINERS:
Get new handguards

4 BOLT CARRIER DOESN'T ALIGN WITH GAS TUBE:
Tell your repairer

6 MAGAZINE DAMAGED OR DIRTY:
Inspect, clean, and lube follower spring; replace damaged magazine

7 TAKEDOWN PIN CORRODED OR STICKS:
Clean and lube

9 BUFFER & SPRING CORRODED:
Clean and lube

11 CHAMBER DIRTY, CORRODED:
Clean chamber with RBC and chamber brush

12 SLIP RING SPRING BROKEN:
Get it replaced
