THE PREVENTIVE MAINTENANCE MONTHLY

TB 43-PS-578

ISSUE 578 JANUARY 2001

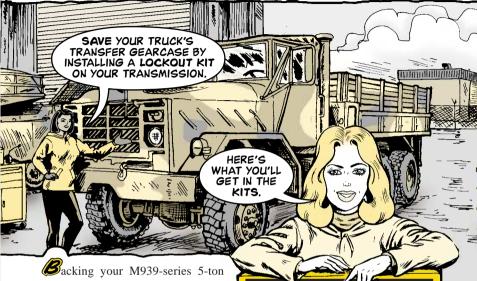
TRANSMISSION LOCKOUT KIT

truck with the transfer gearcase in low range will crack the gearcase.

Drivers are warned about this problem in the -10 TM and every time they get behind the wheel by a warning plate on the dash. Unfortunately, some drivers don't pay attention.

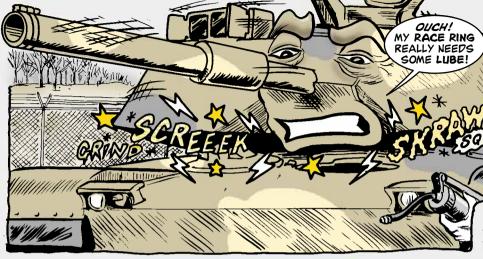
Take a look at the plug on the inner race bearing ring. If it doesn't have a

Before you send the plug off to DS, though, tag it with the tank's serial number. That way each tank gets its original plug back. Each plug is machined to exactly match its race ring. Running your M1 with a plug from another tank will damage ball bearings, springs and the race assembly.

grease fitting, get the MWO applied **now**.

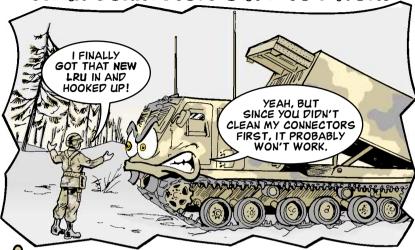
Clean Connectors Save You Work

Brewmen, when a line replaceable unit (LRU) goes bad on your MLRS launcher, you have to replace it. Since the LRUs are heavy and hard to reach, it's not much fun, is it?

You can lessen the chance that you'll have to replace the replacement by cleaning the LRU connectors before hookup. Dirt and moisture get inside the connectors and cause faults that shut you down.

With clean connectors, those new LRUs have a much better chance of doing their job when you hook 'em up.

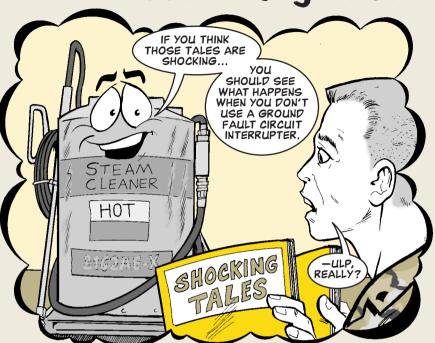
G etting shocked on dry ground is one thing. Getting shocked while soaking wet or standing in water is something else.

That's what can happen if your steam cleaner doesn't have ground fault circuit interrupter (GFCI) protection. A GFCI will shut down equipment when it recognizes a faulty ground.
