ISSUE 394 FIRE POWER AIR MOBILITY

SEPTEMBER 85

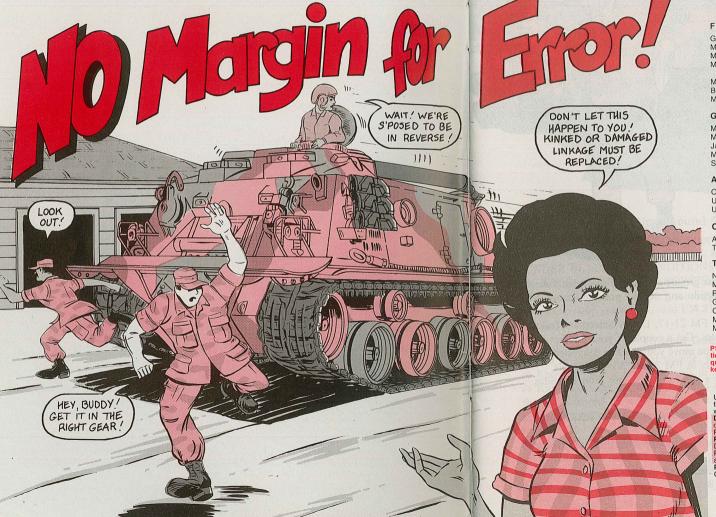
Bent or damaged shifting linkage on your 88 is an open invitation to accident or injury. A soldier was killed recently (COUNTERMEASURE-Feb 85) because an 88 moved forward when the gear selector was shifted to REVERSE but the transmission stayed in 1st gear.

The linkage gets bent or damaged by mechanics stepping on it when they climb out of the hull after the power pack is removed, and when they step on the linkage on top of the transmission while the pack's still in the vehicle.

It's also bent or jammed by equipment like chains, clevises and tools, which

are thrown under the floor plates for storage.

Since there's no margin for error (the linkage either works right or it doesn't), scope out the inspection and alignment check in TB 43-0001-39-3 (Oct 84) on Pages 2-6 and 2-7.

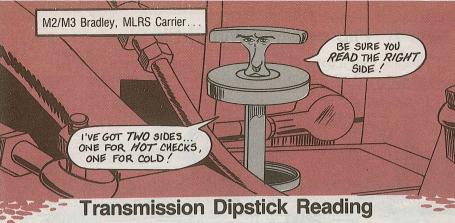
There's a new transmission dipstick that'll soon be showing up for your Bradley or MLRS. It has a gold-colored handle and has markings on both sides. One's for a cold check, and the other's for a hot check.

You use the "cold" side only to make sure it's safe to crank up the engine after an oil change or before troubleshooting for oil leaks.

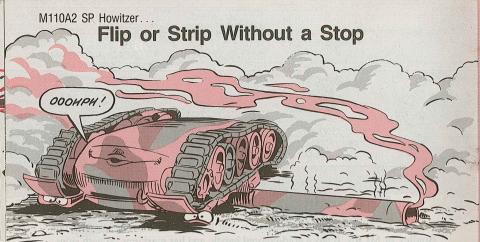
Does your M110A2 have a turret stop? You'd better know before you go! The turret stop prevents the turret from being traversed more than 30 degrees to either side. That's good, because it saves you from two dangerous situations:

Without the stop, the gun could be traversed too far to one side for safe firing. Past 30 degrees, the firing platform is not stable enough to keep the vehicle from flipping. Remember, you don't have a spade on the side.

If the stop is missing, let your mechanic know. The stop's listed as Item 18 in Fig 127 of TM 9-2350-304-20P.

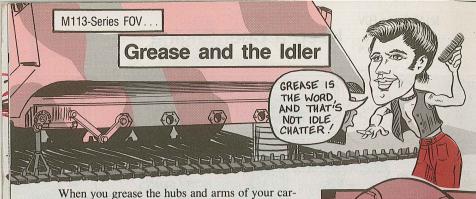
When you grease the hubs and arms of your carrier's roadwheels, don't overlook the fittings on the idler. They need lubing, too.

This is especially true for the grease fitting just above the end of the track adjuster. It's generally covered with mud and overlooked.

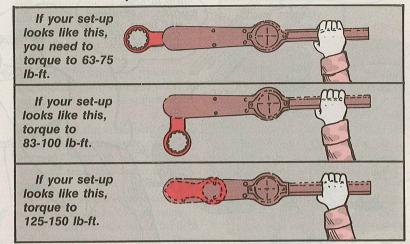
If you use the torque wrench adapter when torquing the bolts on the 7C U-joint on M113-series carriers, remember one thing: You may get more or less torque on the bolt than what you read on the wrench.

In all three situations, you'll be putting 83-100 lb-ft on the bolt.

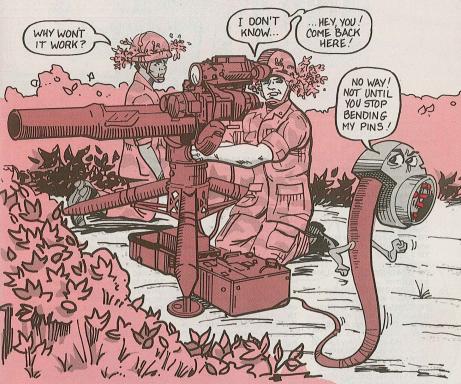
#### **TOW 2 Cable Protection**

Save time and cables on your TOW 2 missile system with a quick look at the alignment marks. Haste makes waste when you force connectors into place. Bent pins put your whole system down.

To connect the 2W1 cable to your missile guidance set (MGS) J1 jack, first

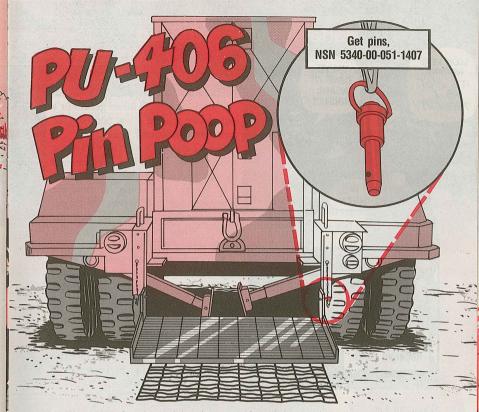
The NSN for the quick-release, self-retaining spring pin that holds your 30-KW generator set's platform assembly in place is 5340-00-051-1407.

The pin is shown on either side of the platform in Fig 5-2 on Page 5-3 of TM 5-6115-365-15.

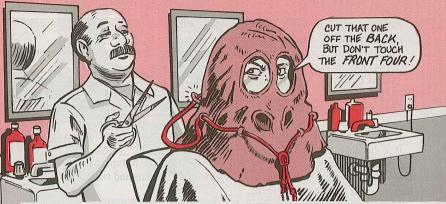
# Clip the M6A2 Loop

Clip the Ripper.

That's the word on the rear drawcord loop of the M6A2 hood used with your M17-series protective masks.

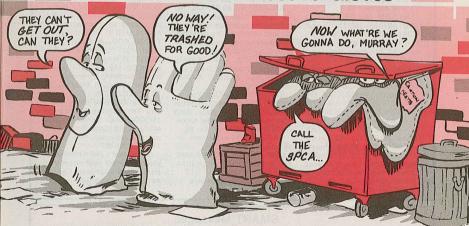
#### **Asbestos-Free Protective Gloves**

You can replace your asbestos-type heat-protective gloves with a pair that contains no asbestos. Use NSN 8415-01-092-3910. There's also an asbestos-free machine gunner's mitten. Get it with NSN 8415-01-092-0039. CTA 50-900 is your authority to order.

The new NSN's replace asbestos gloves, NSN 8415-00-261-7015, and asbestos mitten, NSN 8415-00-266-8843. Both are terminal items on the AMDF. SEP 85
