ISSUE 793 DECEMBER 2018

TB 43-PS-793

**PREVENTIVE** MAINTENANCE MONTHLY

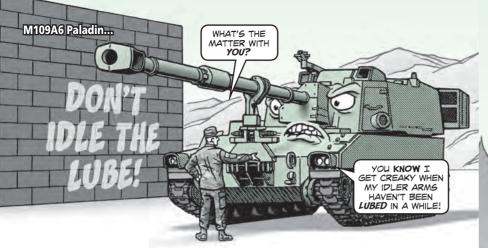
CREWMEN, YOUR PALADIN'S IDLER ARM AND HOUSING CAN TAKE A BEATING DURING MISSIONS. THAT'S WHY YOU NEED TO SHOW IT SOME TLC PURING SEMI-ANNUAL CHECKS AND SERVICES

THERE ARE TWO LUBE POINTS FOR EACH IDLER ARM AND HOUSING.

REMOVE THE PIPE PLUG AND REPLACE IT WITH A GREASE FITTING NSN 4730-00-050-4208, TO LUBE THIS AREA

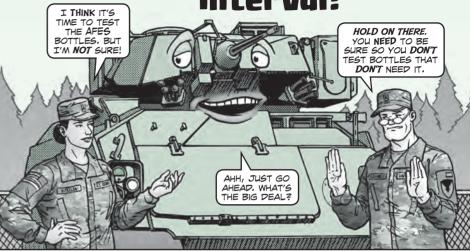
M2/M3-Series Bradleys... AFES Hydrostatic Test Interval?

Mechanics, listen up! There's some confusion about how often the bottles for the Bradley's automatic fire extinguisher system (AFES) should undergo hydrostatic testing.

The right answer is 12 years for bottles that are being recharged. But, that doesn't apply to fully-charged bottles, even if they've gone more than 12 years since the last hydrostatic test.

That means do not remove fully-charged AFES bottles for a hydrostatic test, even if it's been more than 12 years since the last test.

Only test discharged bottles that've gone past the 12year mark since the last hydrostatic test. The bottles need to be recharged after a fire, accidental release or leak. Do **not** discharge an extinguisher just to perform the test.

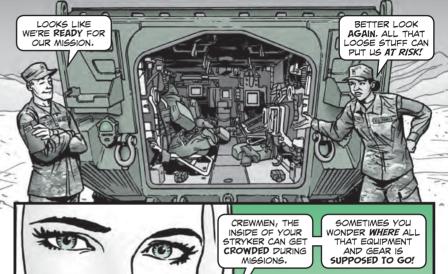
## DON'T STORE GEAR UNDER TROOP SEATS!

NO MATTER HOW TIGHT SPACE IS, NEVER PLACE ITEMS LIKE MRES, AMMO BOXES, TOW BARS, ETC., UNDERNEATH YOUR STRYKER'S ENERGY ATTENUATING (EA) TROOP SEATS, NSN 2540-01-588-8533.

THAT CAN KEEP THE SEATS FROM PROTECTING YOU AND YOUR FELLOW SOLDIERS DURING A BLAST.

Improperly stored equipment and gear can damage energy attenuating (EA) troop seats

THE FOOT REST RAILS.
NSN 2540-01-588-8869,
CAN ALSO BE DAMAGED
BY ITEMS PLACED
UNDERNEATH THE
TROOP SEATS.

REPLACING A FOOT REST RAIL WILL SET YOUR UNIT BACK MORE THAN \$400. ALSO, WHEN REMOVING THE EA SEATS AFTER A MISSION TO CLEAN THE TROOP COMPARTMENT, BE SURE TO KEEP TRACK OF THE MOUNTING HARDWARE. BE CAREFUL HANDLING AND STORING THE SEATS AFTER REMOVAL SO THEY AREN'T DAMAGED.

SO BE SURE TO STORE PERSONAL GEAR AND BII/COEI ITEMS PROPERLY SO THOSE EA TROOP SEATS CAN KEEP YOU SAFE!

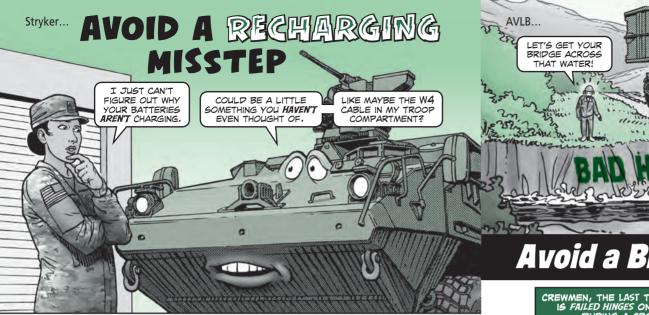
Mechanics, figuring out why a Stryker's batteries aren't charging can be tricky and time consuming. But you might save yourself some trouble by making the W4 cable inside the troop compartment one of your first checks.

The W4 cable that screws into the side of the battery box sits right under the squad leader's seat. The heel of a Soldier's boot can easily hit the W4 cable by accident and either damage it or slowly unscrew it.

A damaged or loosened cable won't allow the vehicle's batteries to charge. So a quick check of the W4 cable might just get those batteries recharging in a hurry.

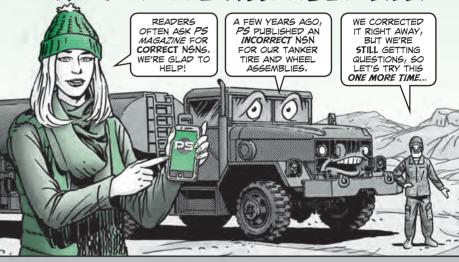
TO ORDER A REPLACEMENT TIRE AND WHEEL ASSEMBLY FOR THE M967A1 AND M969A1/A2 FUEL TANKER, USE NSN 2530-01-506-4125.

THAT BRINGS A NEW 22.5-IN TUBELESS TIRE WITH A ONE-PIECE WHEEL (WHICH IS ALSO THE **SAME TIRE** USED ON THE NEW PRODUCTION M967A2 AND THE M969A3).

BUT **DO NOT** MIX 20-IN AND 22.5-IN ASSEMBLIES ON THE **SAME TRAILER**. THAT CAUSES THEM TO WEAR OUT QUICKER THAN THEY SHOULD.

REPLACE ALL OF THE TRAILER'S TIRE AND WHEEL ASSEMBLIES AT THE SAME TIME TO PREVENT IMPROPER WEAR. THAT'S A TOTAL OF NINE ASSEMBLIES, INCLUDING THE SPARE!

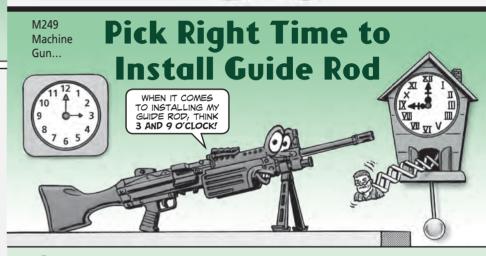
Soldiers are installing the M249 machine gun's guide rod assembly wrong. Eventually, that damages the receiver so much it must be replaced.

The guide rod has two pins. When you install the guide rod, they should be at the 9 and 3 o'clock positions. That way they lock the guide rod in the rear of the M249.

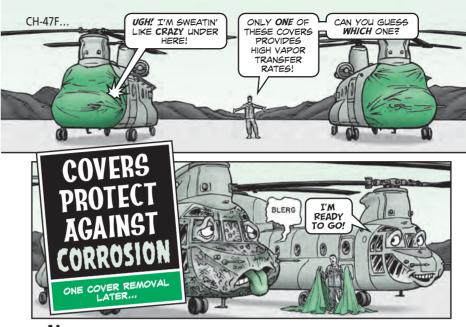
MECHANICS, WHEN FIGHTING TO PROTECT YOUR CHINOOK FROM THE ONSLAUGHT OF CORROSION, YOU NEED ALL THE TOOLS YOU CAN GET!

AIRCRAFT COVERS ARE A NECESSARY PART OF YOUR AIRCRAFT PROTECTION ARSENAL. SURE, THEY'RE HARD TO USE. BUT WITHOUT THEM, YOUR AIRCRAFT IS YOULNERABLE.

THE CHINOOK AIRCRAFT COVERS HAVE HIGH VAPOR TRANSFER RATES AND SHIELDING PROPERTIES THAT PROVIDE ENVIRONMENTAL AND CORROSION PROTECTION. THAT MEANS THERE'S NO SWEATING LINDER THE COVERS THAT CREATES AN ENVIRONMENT FOR CORROSION.

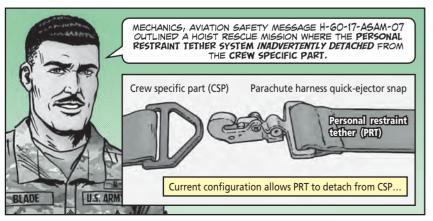
AFTER AN INVESTIGATION, PM AIR WARRIOR PETERMINED THAT DYNAMIC ROLLOUT CAUSED THE PRT PARACHUTE HARNESS QUICK-EJECTOR SNAP TO RELEASE FROM THE CSP.

THE EJECTOR SNAP AND CSP GOT TWISTED OR SNAGGED ON ANOTHER PIECE OF EQUIPMENT.

ALSO, AS A RESULT OF THE ASAM, PM AIR WARRIOR DEVELOPED AND IS ISSUING UNITS NEW PERSONAL RESTRAINT TETHERS FOR FREE.

UNITS WILL RECEIVE ONE PRT FOR EACH NON-RATED CREWMEMBER.

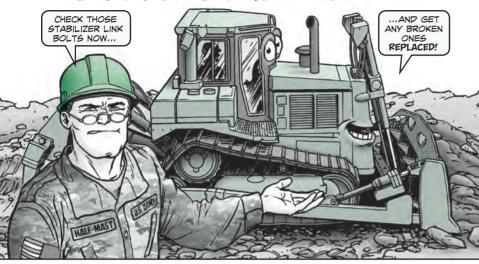
### DTR II DOZER GET BROKEN STABILIZER MOUNTING BOLT REPLACED FREE

perators, take a minute to eyeball the condition of the Grade 5 mounting bolts on your D7R II dozer's stabilizer link.

BROKEN STABILIZER LINK BOLTS ON THE DOZER'S ROADSIDE AND

See a busted bolt? Your maintenance tech can have it replaced at no cost by contacting a local CAT dealer. Find yours by searching at:

The dealer will replace the left- and right-hand mounting bolts with a Grade-8 bolt, NSN 5306-01-580-2030, and torque it to 430 lb-ft.

This warranty repair is only available to dozers with serial numbers KNA01530 through KNA01733. Use CAT service letter PS45607 to schedule the repair.

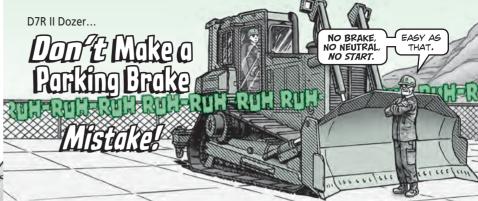
Operators, it's a real easy mistake to make: You hop in the cab and start cranking on the engine starter, but your D7R II dozer doesn't start and you're going nowhere.

And guess what? You can try all day long-or at least until the battery goes dry or the starter burns out—but unless you engage the parking brake and the transmission control switch is in neutral, that dozer ain't startin'!
