THE PREVENTIVE MAINTENANCE MONTHLY

TB 43-PS-585

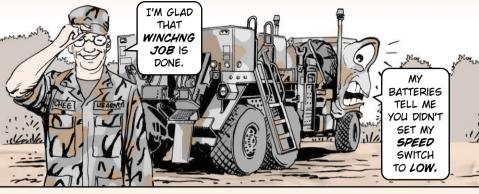
Move Switches to Save Batteries

When you've finished winching operations with your M1089 wrecker, make sure the batteries don't run down before your next mission.

Both main winch speed switches on the remote control panel must be set to LOW at shutdown. And the STATION

SELECTOR switch on the fixed control panel must also be set to WRECKER CONTROL PANEL. TM 9-2320-366-10-2 fails to mention either setting.

If you leave the speed switches set to HI and the selector switch set to REMOTE CONTROL, battery power continues to go to the remote control panel. That can kill your vehicle's batteries.

Until the TM is updated, note this information and save some battery money and slaving time.

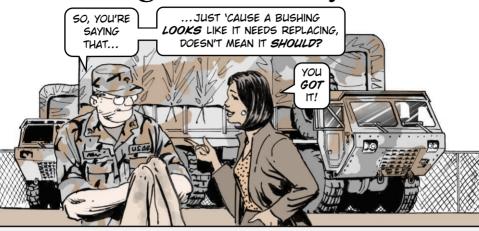
Bushings Worn? Maybe Not

Mechanics for PLS tractors and HEMTTs, take note: Cracked or wrinkled paint alone does not identify equalizer beam bushing wear. Neither does a minor cut or two.

Cracked or wrinkled paint can make bushings look like they're dry rotted when they're not. Cuts and gouges can make them look ready for the scrap heap when they're really OK.

But never send your PLS tractors or HEMTTs to support for bushing replacement unless you detect movement in the bushings. If they are turning (look for signs of movement against the beam bore) or wallowing (the bushing is narrower in some spots than others), they're shot. Otherwise, keep on truckin'.

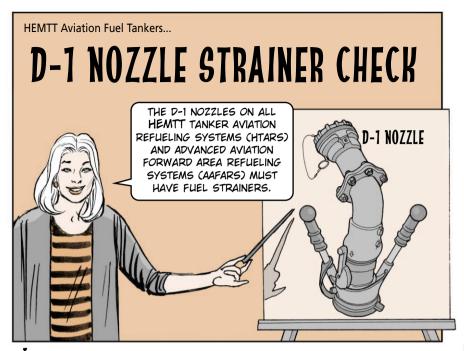
If they don't, a stuck shut-off valve could soak you in fuel or, much worse, cause a fire. Some D-1 nozzles made by Carter Ground Fueling Co. may not have the strainer, which is necessary to prevent fuel debris from lodging in the shut-off valves or

If your AAFARS uses a Carter nozzle, remove it and look for the strainer. If the strainer is present and not torn or obstructed, clean it and reinstall the nozzle. If the strainer is missing, torn or damaged, replace it with part number (PN) 47115-100.

If your HTARS uses a Carter nozzle, remove it and check the strainer. If it's present and not torn or obstructed, clean it and reinstall the nozzle. If the strainer is missing, install a new non-valved unisex coupling, PN 64019CN, that will accept a strainer.

If the strainer is torn or damaged, replace it with PN 47115-100. Dispose of the bad strainer.

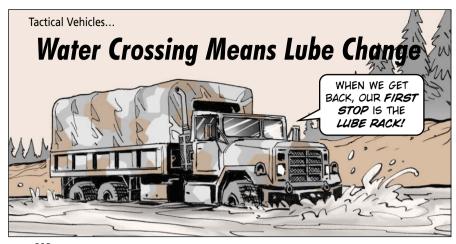
Water and oil don't mix.

Keep those words in mind when you ford a hub-deep stream with hot axle housings.

Water will cool hot metal and create a vacuum inside those housings. The vacuum draws water past the axle seals and into the gear oil. Water-contaminated oil is a poor lubricant, so gears wear and fail. Contamination can happen whether you ford a stream or just drive through hub-deep water. So how can you know for sure that water has been sucked into the axle housing? You can't. The point is that you should take no chances on ruining differential gears. After a run through water, remember that your mechanic has a lube job to do when you get back to the motor pool.

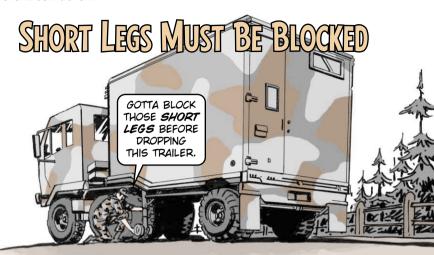
Pulling an M373A2 electronics semitrailer behind an M931-series tractor or an M1088 FMTV tractor is no problem at all. But hooking up to one, or unhooking from one, can be a big problem.

Both the M931 and the M1088 tractors are tall at the fifth wheel—tall enough that the landing legs of the M373A2 don't touch the ground even when they're fully extended.

Unless you block underneath the legs, that trailer is going to drop when you pull out from under it. The drop can damage the legs, or maybe even cause them to collapse. Even if neither of those things happen, you're still going to have it tough trying to hook up to the trailer next time.

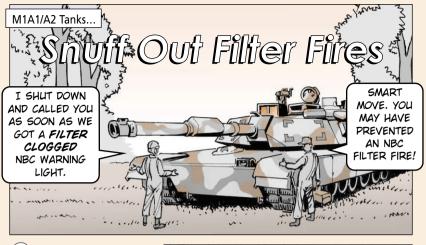
Overheating is the main cause of M48 NBC filter fires on your M1A1/A2 tank. But you can prevent that overheating by watching for these warning signs:
☐ Low or no air flow at the NBC hose sockets or bulk

If any of these things happen, the filters can catch fire unless you shut down the main NBC system immediately.

If you need clean air, activate the backup NBC system. While the backup system doesn't provide cooled air, it does give you filtered air from outside the tank.

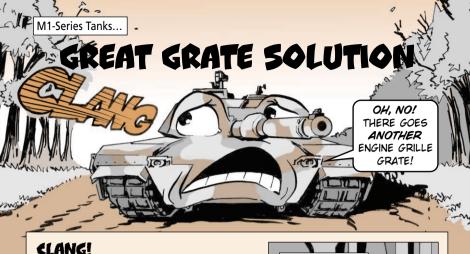
CLANG!

That's the all-too-familiar sound of of the grille door grates falling off the back of your tank when the grate bolts vibrate loose.

The key washers wrap around the bolt head and the grate clamp to keep the bolt from vibrating loose.

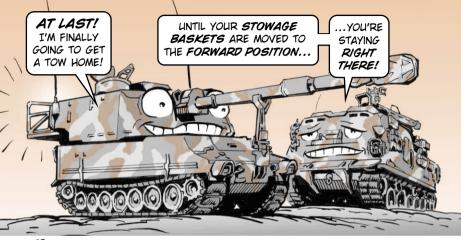
DON'T BE A BASKET CASE

How you prepare a disabled M109A6 Paladin for towing will determine the shape of its stowage baskets when you get back to the motor pool.

If the baskets are locked in the rear position and a tow bar is used, the baskets may hit the M88A1 recovery vehicle during turns. That can damage the baskets or even rip them completely loose. It doesn't do the M88A1 any good either.

Any time you must tow a Paladin with the baskets in the rear position, use a ground guide to prevent damage during turns.

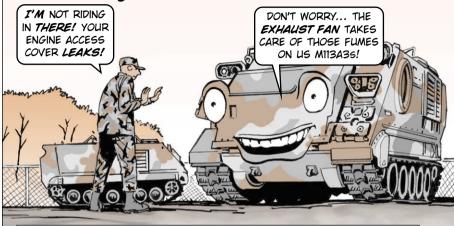
Leaky Covers Not NMC

The -10 TMs say your M113-series FOV is NMC if the driver's compartment or rear compartment engine access covers are bent or have torn seals.

The M113A2 TM is right, but TACOM now says the M113A3 TM is wrong. The reason is the different exhaust fan used in each vehicle.

The M113A2 fan blows air **into** the engine compartment. That means a bent engine access cover or damaged seal could let harmful exhaust gases into the crew compartment.

But the M113A3 fan pulls air **out of** the engine compartment. Since exhaust gases can't get into the crew compartment, a bent access cover or damaged seal

The weekly exhaust pipe PMCS checks listed as Item 56 in TM 9-2350-261-10 and Item 59 in TM 9-2350-277-10 are still required. If any part of the exhaust pipes is missing, damaged, poorly aligned or not securely mounted, your vehicle is still NMC.

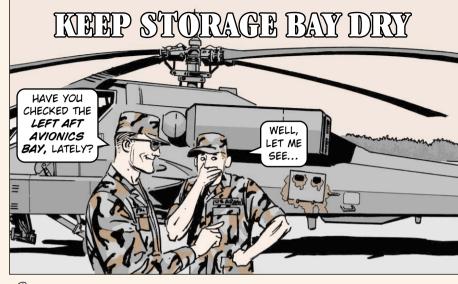
Grew chiefs, MWO 1-1520-238-50-50 moved the AN/AVR-2A(V)1 laser detection comparator and the AN/APR-39A digital processor into the Apache's left aft storage bay (L295) to keep them dry. It worked on the AH-64D, but a water problem still exists on the AH-64A.

That's because on the A model the cable harnesses for those components are routed through holes at stations 285 and 305—now called the left aft avionics bay—which cannot be sealed. So rain water, wash water, condensation and even hydraulic fluid can enter the bay, following the cable bundles. It then leaks onto the avionics. Because the digital processor sits on the shelf, it allows water to wick in from underneath.

But until the headshed comes up with a permanent fix for the leaky bay, take extra care not to direct water at the ventilation holes which help cool the avionics bay. Then inspect the bay for water and corrosion after you wash your bird or fly in the rain. Mop up any liquid on the avionics and the mounting area with a clean cloth and treat any corrosion you find.

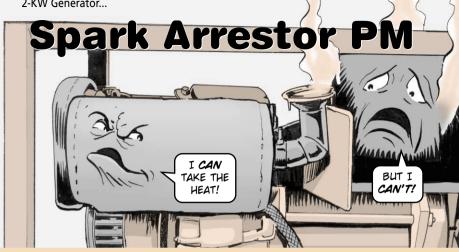
A hard-starting MEP-531A or MEP-501A 2-KW generator means it's time to clean the spark arrestor and diffuser discs. The TM is being changed to require that the spark arrestor and its diffuser discs be cleaned after 50 hours of operation instead of after 100 hours. But until the TM is revised, clean the arrestor and its discs as needed.

Take the arrestor apart and clean the discs with an approved cleaning solvent and a wire brush. Clean the entire arrestor, including the end cap.

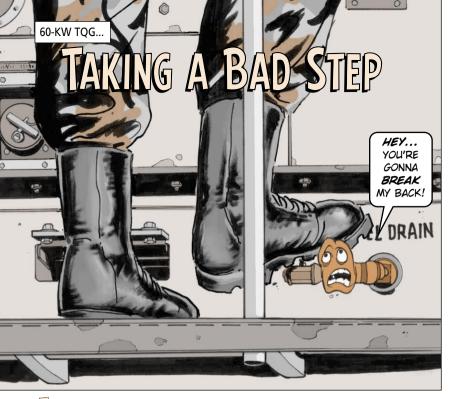
The skid-mounted 60-KW tactical quiet generator (TQG) is suffering under the weight of some big-foot abuse.

Located right in the middle of the left-side skid is the fuel drain. If you need to look on top of the generator or over it, that fuel drain seems like the perfect place to step. But the drain was never meant to take on that kind of weight. You'll bend or break the pipe and bust off the T-valve.

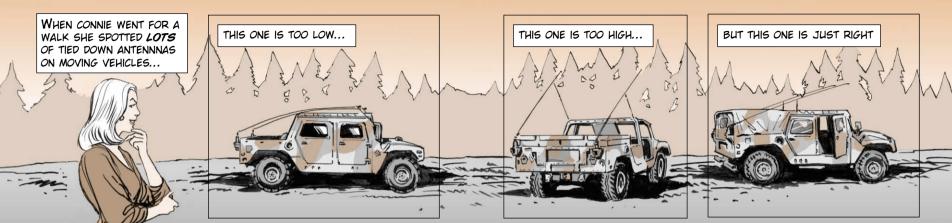
ON THE MOVE AND PARKED

Eley, vehicle operators, some safety people are not too happy with some of you. Seems they've spotted a whole lot of vehicular antennas waving in the wind as you cruise around post. Tying down your antennas to keep them from striking a power line or an overhead bridge is the only safe way to go.

The maintenance folks are not too happy with some of you, either. Seems they have spotted a whole lot of vehicular antennas tied down while the vehicle is parked overnight in the motor pool. That unnecessary stress on the base spring weakens it. Also, an upright antenna keeps the base spring coils close together, which helps keep out moisture and dirt.

Get a tiedown kit for your AS-3900 antenna with NSN 4020-01-341-8795. NSN 4020-00-908-6416 brings a tiedown kit for the AS-1729 antenna.
